**AquaServe Management Ltd**

| <b>Water:</b> | Village Pond (East End Pond) | <b>Total Area:</b> | 1,316 square metres |

## Waterway Health and Safety Risk Assessment

East End Pond, East End Play Area, Langtoft, Peterborough, PE6 9LP

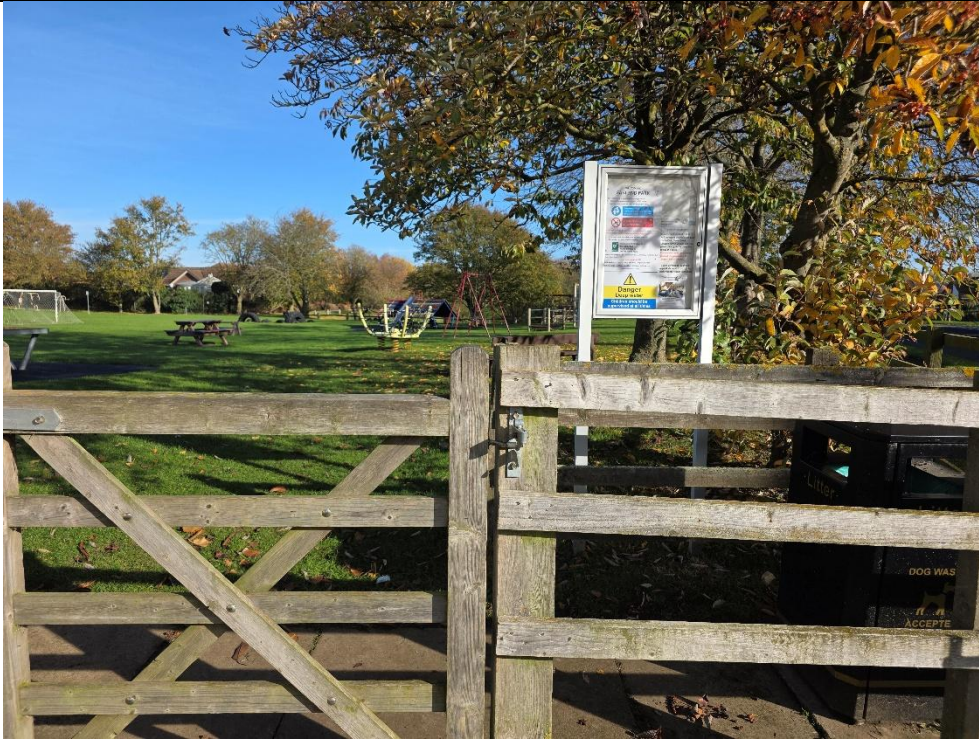
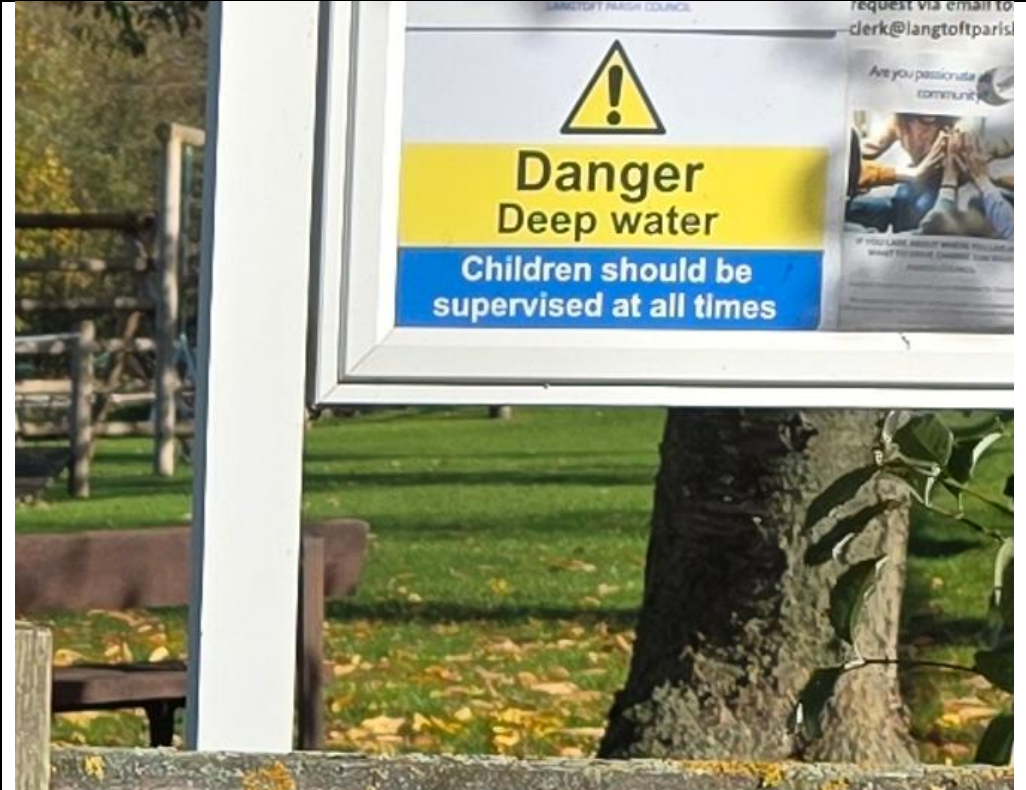
1A, 1B, A pedestrian gate to the recreational area. Entrance signage includes a Danger Deep water sign (///eliminate.belief.region)

| Description | Priority |
|---|---|
| <p>There is an inconsistency created by installing warning signage at or near two of the three entrances to the park. Any harm suffered by a user entering by the footpath entrance to the park could be more culpable.</p> <p>Whilst current signage reminds park users that "Children should be supervised at all times", they are specifically "Danger Deep water" signs. These could infer that children only need to be supervised around the pond.</p> <p>Warning signage should also highlight uneven ground and risk of falling as potential hazards.</p> <p>The "Children should be supervised at all times" should be relevant to all hazards.</p> <p>The recommended signage strategy is "Entrance" and "Reminder" signs.</p> <p><b>Entrance signs</b> are clear signage at all entrances, highlighting all of the significant hazards in the park area.</p> <p>Entrance signs warning of "Deep Water", "Uneven Ground" and "Risk of falling" are recommended at all three entrances.</p> <p>These should also include the mandatory (white on blue) notice that "Children should be supervised at all times" and the information sign (green background with white text and symbols) "In the event of a person falling into the water, DIAL 999 and ask for the FIRE BRIGADE". The sign should also quote the relevant What3Words location.</p> <p><b>Reminder signs</b> are specific to one hazard and installed in areas of higher risk.</p> <p>Two "Danger Deep Water", "Uneven Ground", "Children should be supervised at all times" signs should be installed on the knee high, single bar rustic fence, and on the edge of the pond near the footpath entrance.</p> <p>A "Danger, Risk of falling", "Danger Deep Water", "Uneven Ground", "Children should be supervised at all times" sign should be installed on the "Log Pile".</p> <p>"Danger, Risk of falling", "Children should be supervised at all times" signage should be installed on the two culvert fences.</p> <p><b>An information sign</b> (green background with white text and symbols) should be mounted on the lifebuoy stand stating, "In the event of a person falling into the water, DIAL 999 and ask for the FIRE BRIGADE". The sign should also quote the What3Words location <a href="#">"///reports.condensed.springing"</a>.</p> | 2 |

| Entity or Hazard | Potential Harm | Control measures in place | C | L | RR | Additional control measures required | C | L | ARR | Pics |
|---|---|---|---|---|---|---|---|---|---|---|
| Warning signage | Harm or litigation due to insufficient hazard warnings. | <p>“Danger Deep water, Children should be supervised at all times” signage has been installed at or near two of the three entrances to the park.</p> <p>A “Lifebuoy with Line” sign has been installed on the lifebuoy stand.</p> | 4 | 2 | 8 | <p>There is an inconsistency created by installing warning signage at or near two of the three entrances to the park. Any harm suffered by a user entering by the footpath entrance could be more culpable.</p> <p>The recommended signage strategy is “Entrance” and “Reminder” signs.</p> <p><b>Entrance signs</b> are clear signage at all entrances, highlighting all of the significant hazards in the park area.</p> <p>Entrance signs warning of “Deep Water”, “Uneven Ground” and “Risk of falling” are recommended at all three entrances.</p> <p>These should also include the mandatory (white on blue) notice that “Children should be supervised at all times” and the information sign (green background with white text and symbols) “In the event of a person falling into the water, DIAL 999 and ask for the FIRE BRIGADE”. The signs should also state the relevant What3Words locations.</p> | 4 | 1 | 4 | 1A, 1B, 1F, 1G, 1T. |

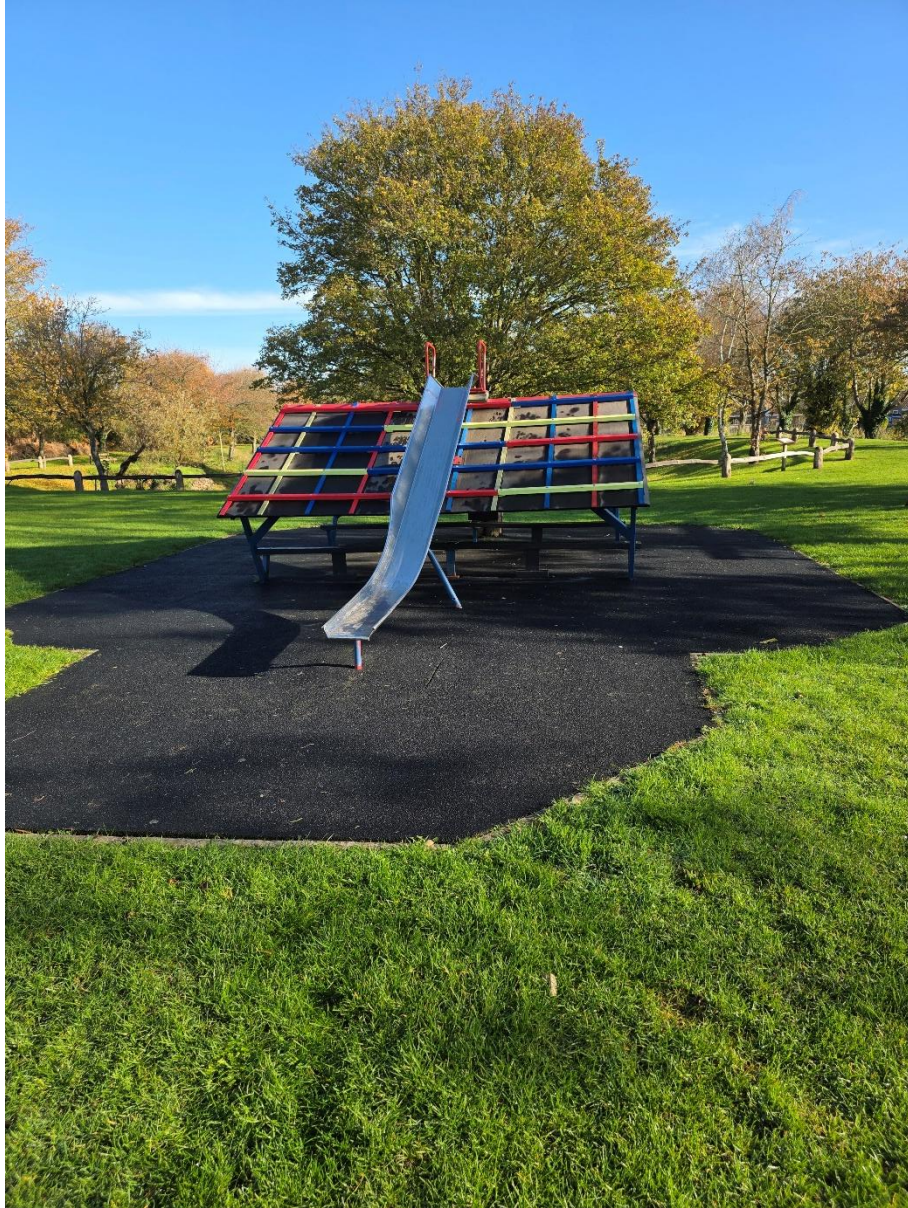
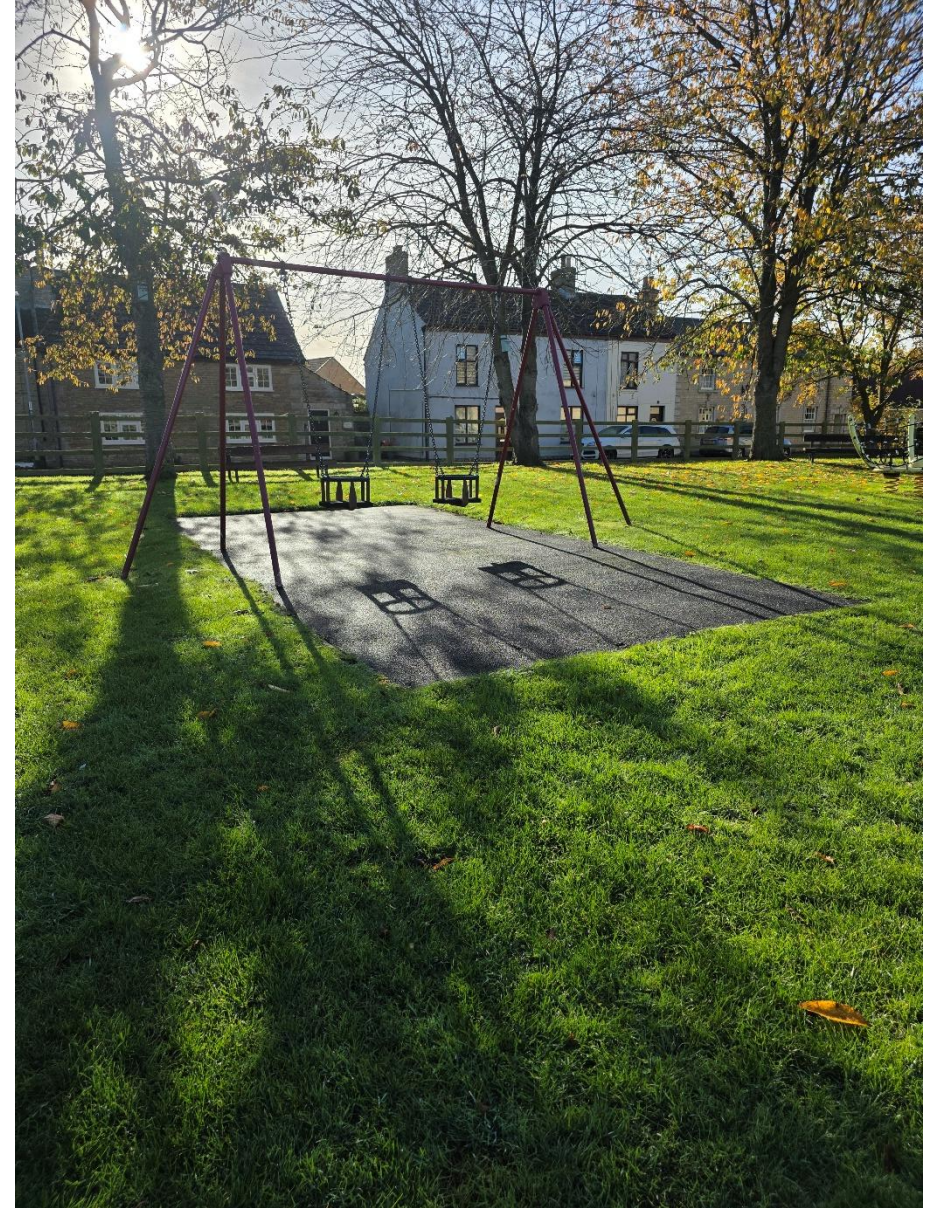
1C, 1D, A well installed play area and sports field is in the recreational park adjacent to the pond (///overlaid.view.princes).

| Entity or Hazard | Potential Harm | Control measures in place | C | L | RR | Additional control measures required | C | L | ARR | Pics |
|---|---|---|---|---|---|---|---|---|---|---|
| Play area and sports field | <p>Slips, trips and falls from uneven ground.</p> <p>Falls from height, cuts and puncture injuries from deteriorating play equipment.</p> <p>Potential for cuts, bruises, sprains and fractures.</p> | <p>The play area has been well designed and installed professionally.</p> <p>The play area and sports field were in very good order.</p> <p>There are regular “walk around inspections” by Parish Councillors.</p> <p>Play equipment is inspected and maintained by a competent contractor every year.</p> <p>Users of the area have a legal duty to take reasonable care of their own safety.</p> <p>Signage reminds park users that “Children should be supervised at all times”.</p> | 4 | 2 | 8 | <p>Whilst current signage reminds park users that “Children should be supervised at all times”, they are specifically “Danger Deep water” signs. These could infer that children only need to be supervised around the pond.</p> <p>Warning signage should also highlight uneven ground and risk of falling as potential hazards.</p> <p>The “Children should be supervised at all times” should be relevant to all hazards.</p> | 4 | 2 | 8 | 1C, 1D, 1E. |

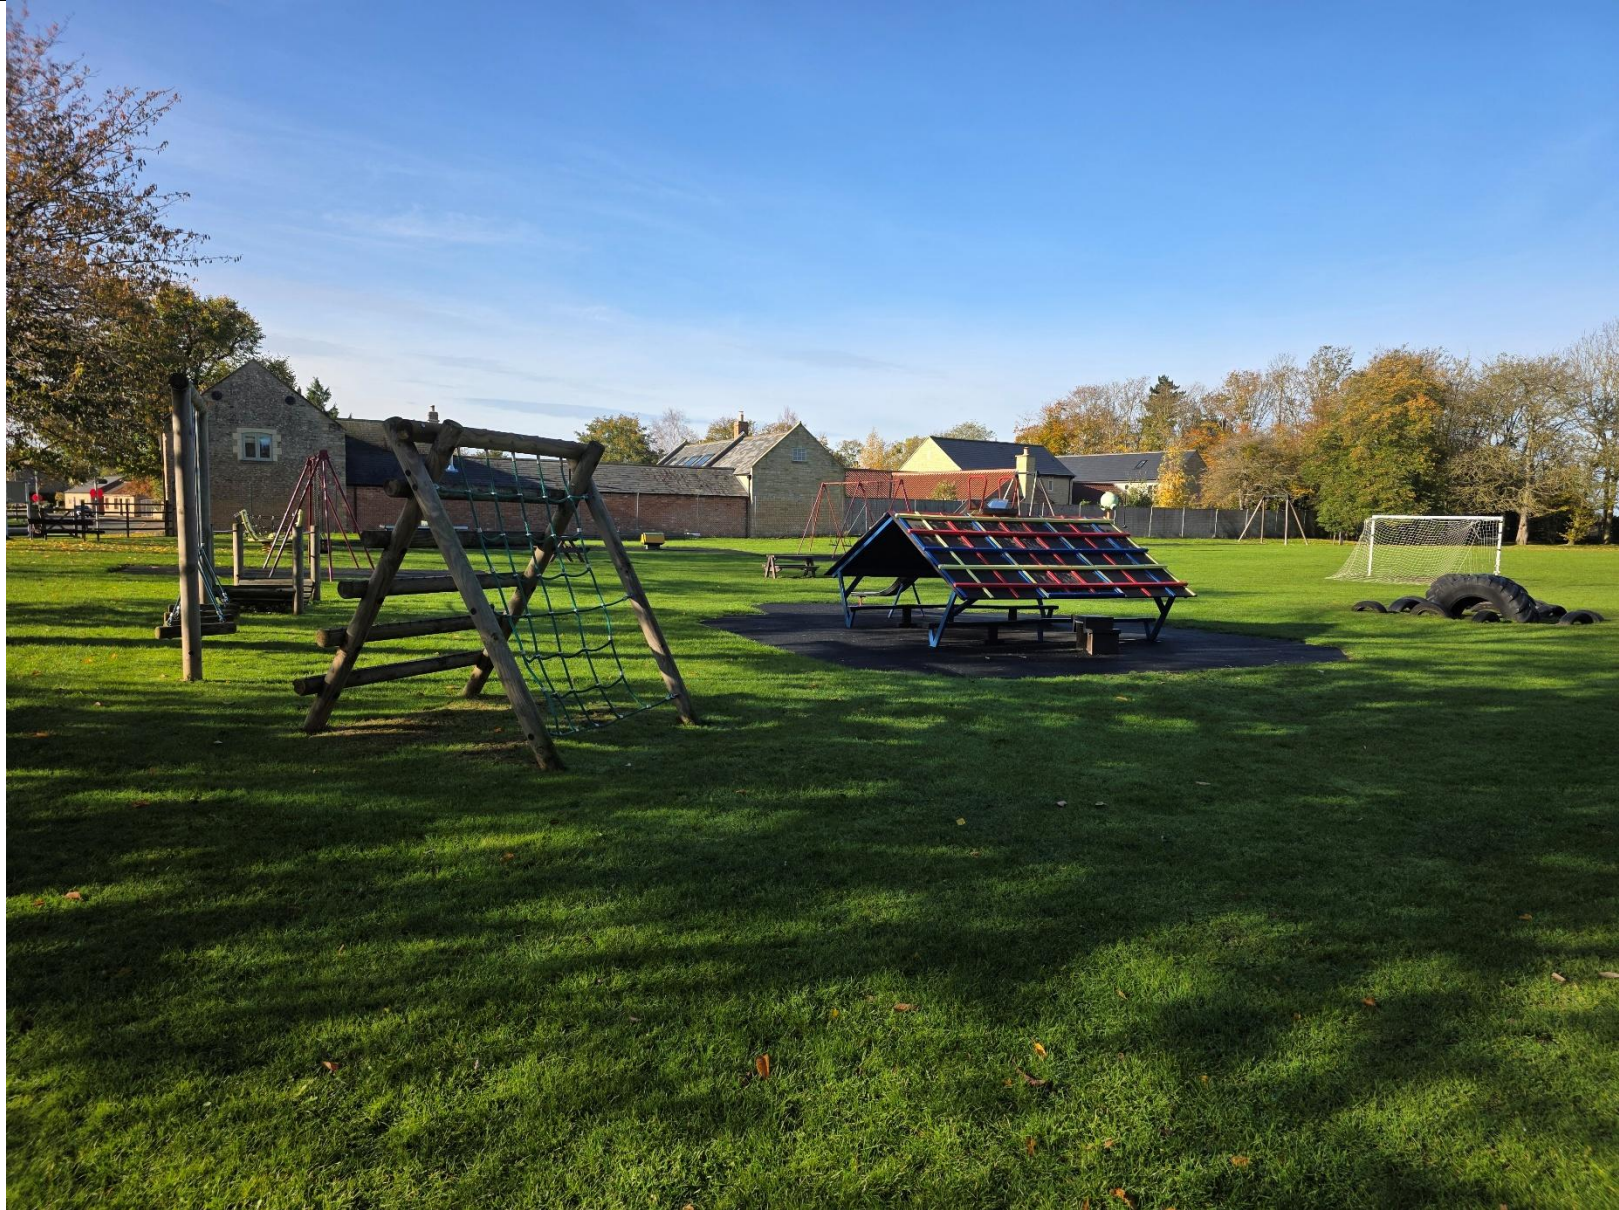
1E, A well installed play area and sports field is in the recreational park adjacent to the pond (///overlaid.view.princes).

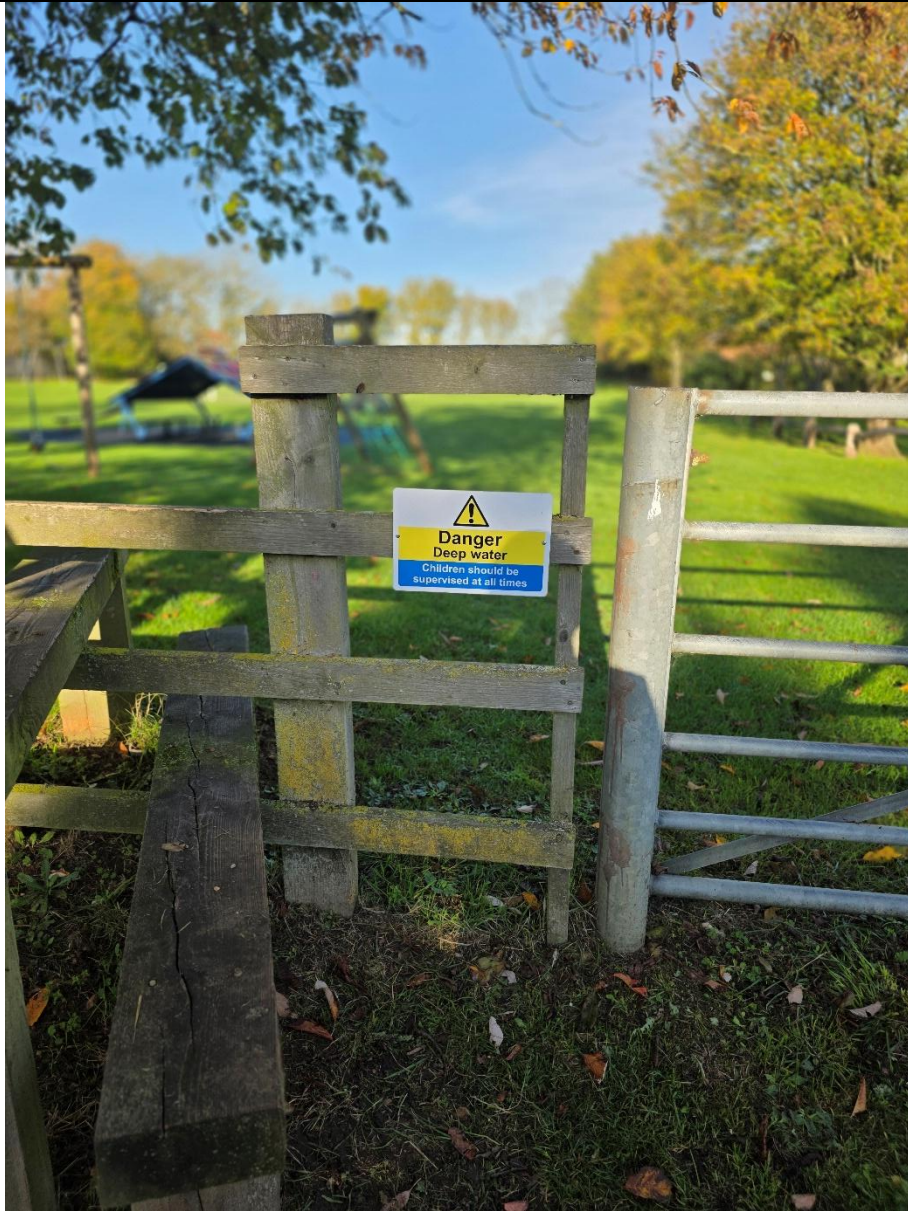
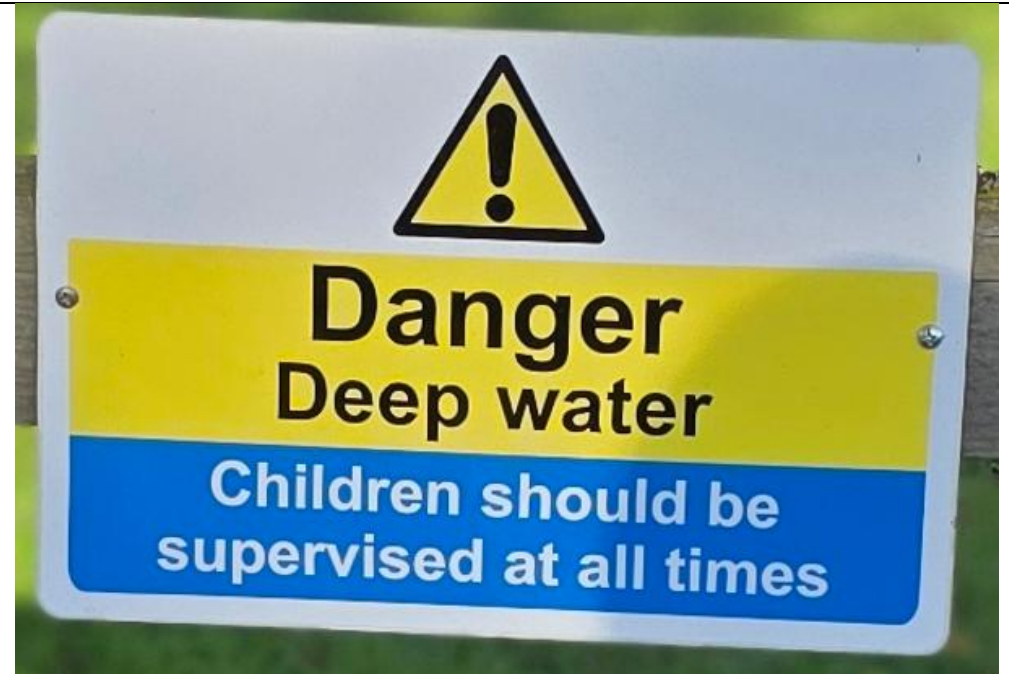
1F, 1G, Danger Deep water sign at the gate and stile entrance to the park (///oldest.neckline.sneezed).

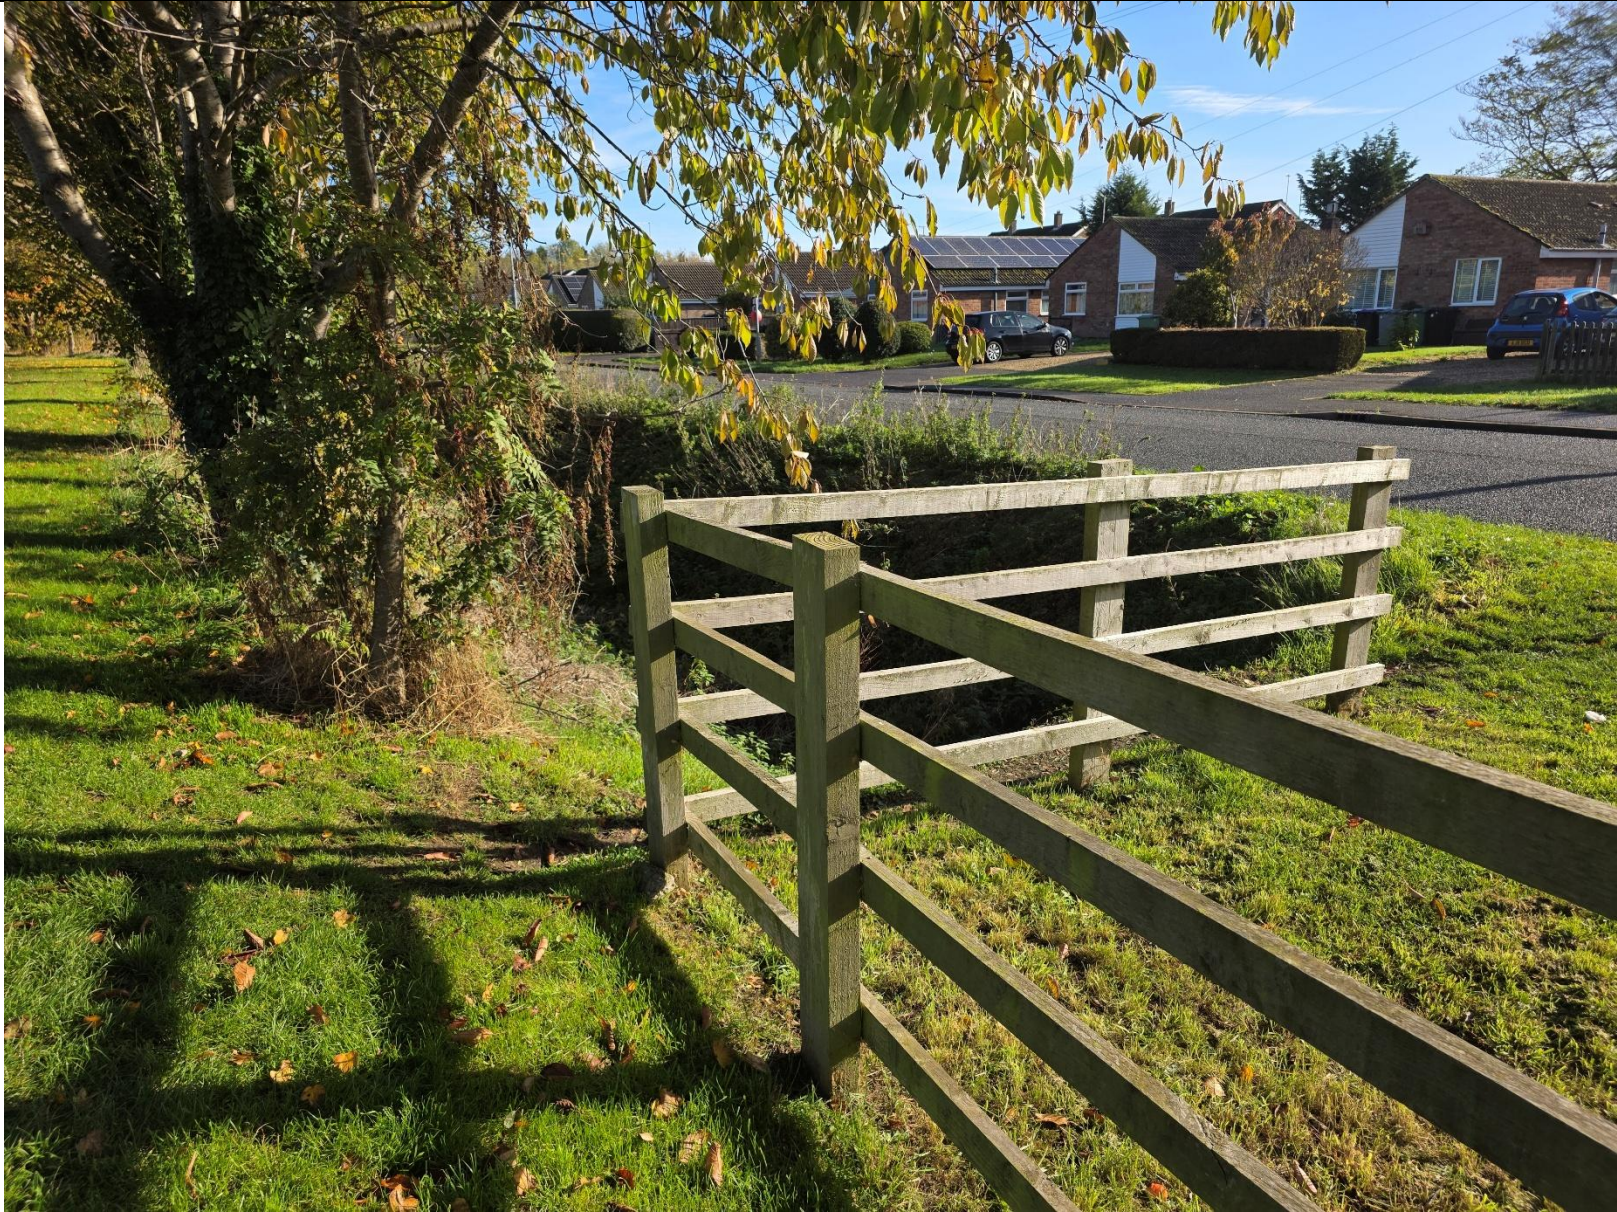
1H, From the gate, this 1.5 metre tall, 4-bar fence extends to guard access to a culvert at the start of a 2-metre-deep ditch with steep sides. The culvert can still be accessed from the sides of the fencing ([///calendars.biked.minds](http://calendars.biked.minds)).

| Description | Priority |
|---|---|
| <p>There is an inconsistency created by fencing the culvert near the gate and stile entrance to the park and not fencing the equally accessible culvert at the footpath entrance. A fall from the latter is foreseeable, could result in significant harm and the inconsistency in guarding could increase culpability.</p> <p>It is strongly recommended that the culvert at the footpath entrance to the park should be fenced.</p> | 1 |
| <p>A "Danger, Risk of falling" sign on each of the culvert fences could further decrease the risks of harm and litigation.</p> | 2 |

| Entity or Hazard | Potential Harm | Control measures in place | C | L | RR | Additional control measures required | C | L | ARR | Pics |
|---|---|---|---|---|---|---|---|---|---|---|
| Culverts | <p>Falls from structures onto ground or into water from height.</p> <p>The resulting harm could include cuts, bruises, sprains, fractures or drowning.</p> <p>Harm caused by a fall from a built structure is more likely to be result in a claim or liability.</p> | <p>Wide walkways around the park are well maintained. There is no obvious reason why users would approach the culverts other than play.</p> <p>Whilst the culvert could still be accessed, the access to one of the two culverts was deterred by a 1.5 metre tall, 4-bar fence.</p> <p>There is no pavement installed on the roadside adjacent to the ditch. Vegetation is maintained in a manner to further deter access to the ditch and culverts.</p> <p>Users of the area have a legal duty to take reasonable care of their own safety.</p> <p>Signage reminds park users that "Children should be supervised at all times".</p> <p>The Parish Council inspects and maintains the pond and recreation ground.</p> | 4 | 3 | 12 | <p>There is an inconsistency created by fencing the culvert near the gate and stile entrance to the park and not fencing the equally accessible culvert at the footpath entrance. A fall from the latter is foreseeable, could result in significant harm and the inconsistency in guarding could increase culpability.</p> <p>It is strongly recommended that the culvert at the footpath entrance to the park should be fenced.</p> <div data-bbox="1361 644 1496 861"> <p><b>Danger</b><br/>Risk of falling</p> </div> <p>A "Danger, Risk of falling" sign on both fences could further decrease the risks of harm and litigation.</p> <p>Warning signage should also highlight uneven ground and risk of falling as potential hazards.</p> <p>Continue the thoughtful programme of inspection and maintenance.</p> | 4 | 2 | 8 | 1H, 1I, 1Z, 1AA, 1AB. |

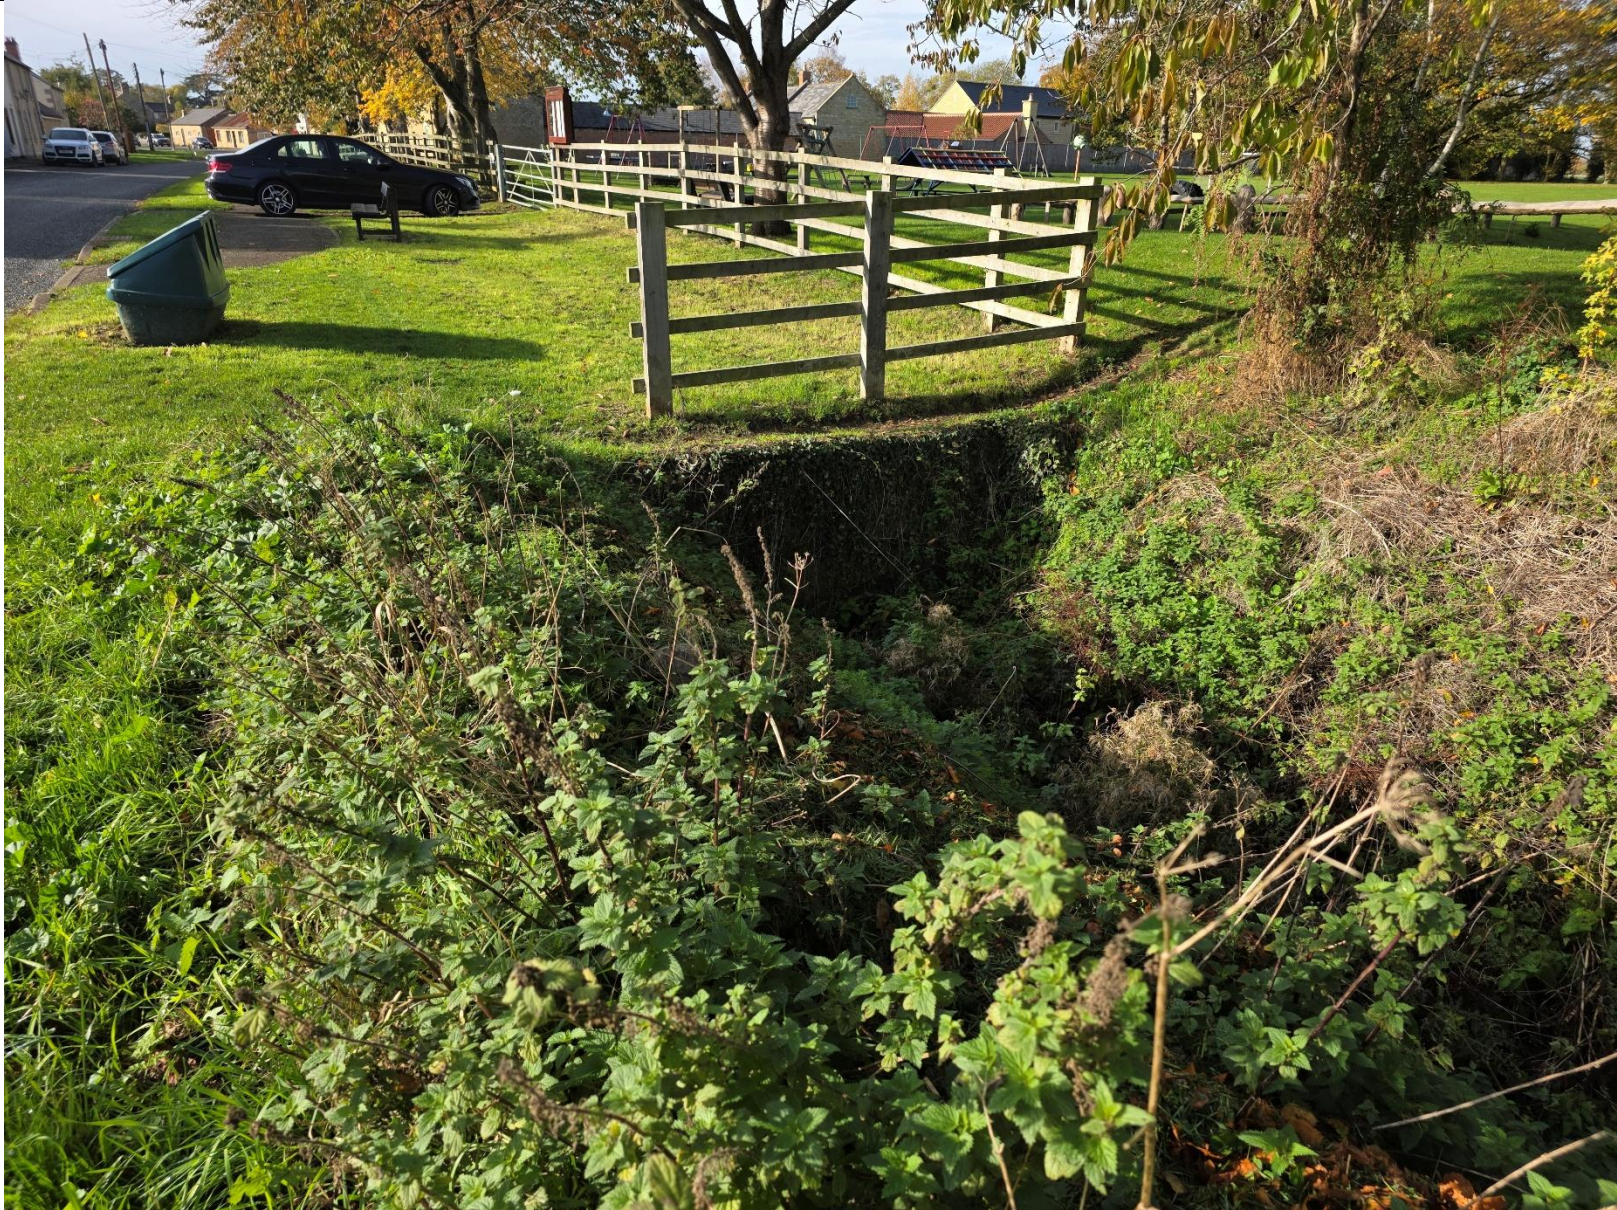
11, The culvert can still be accessed from the sides of the fencing (<http://calendars.biked.minds>).

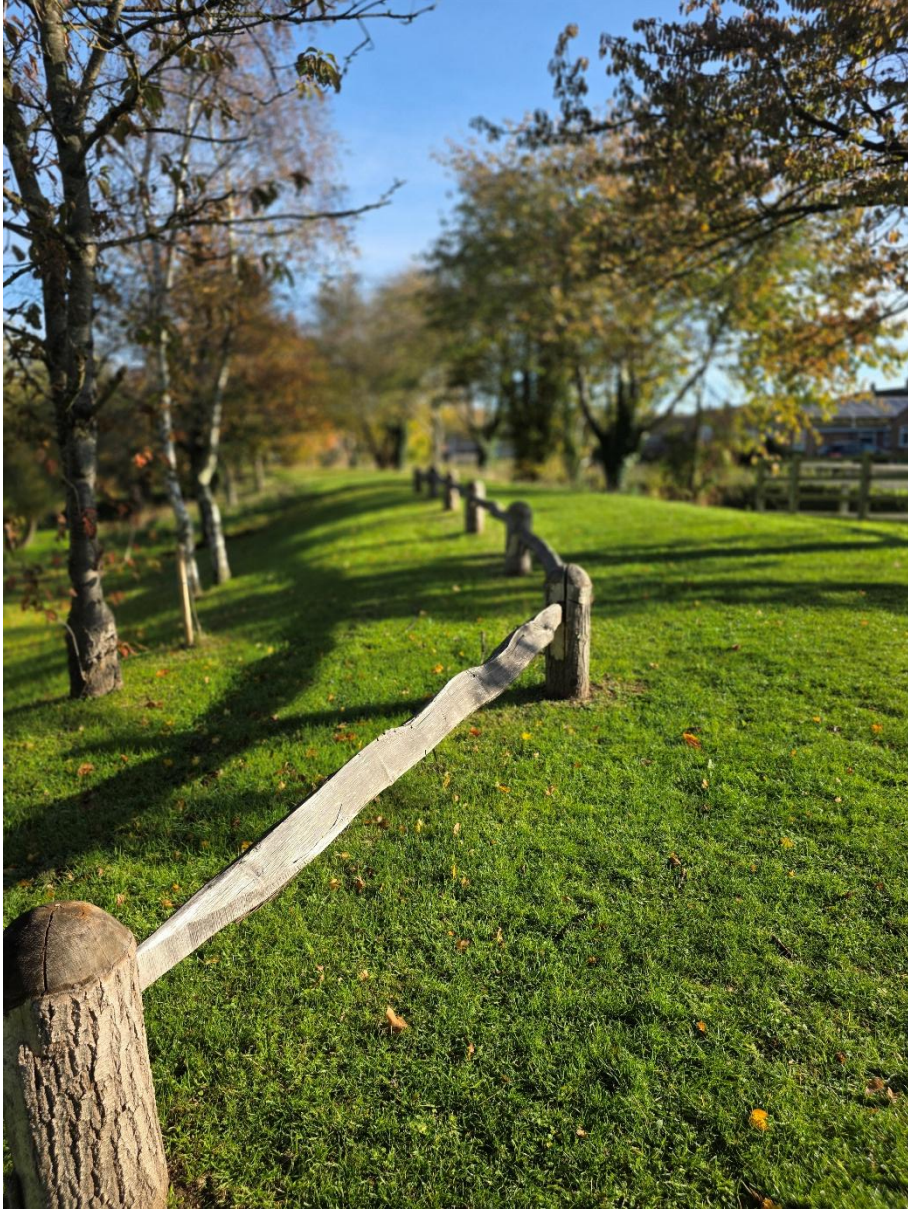
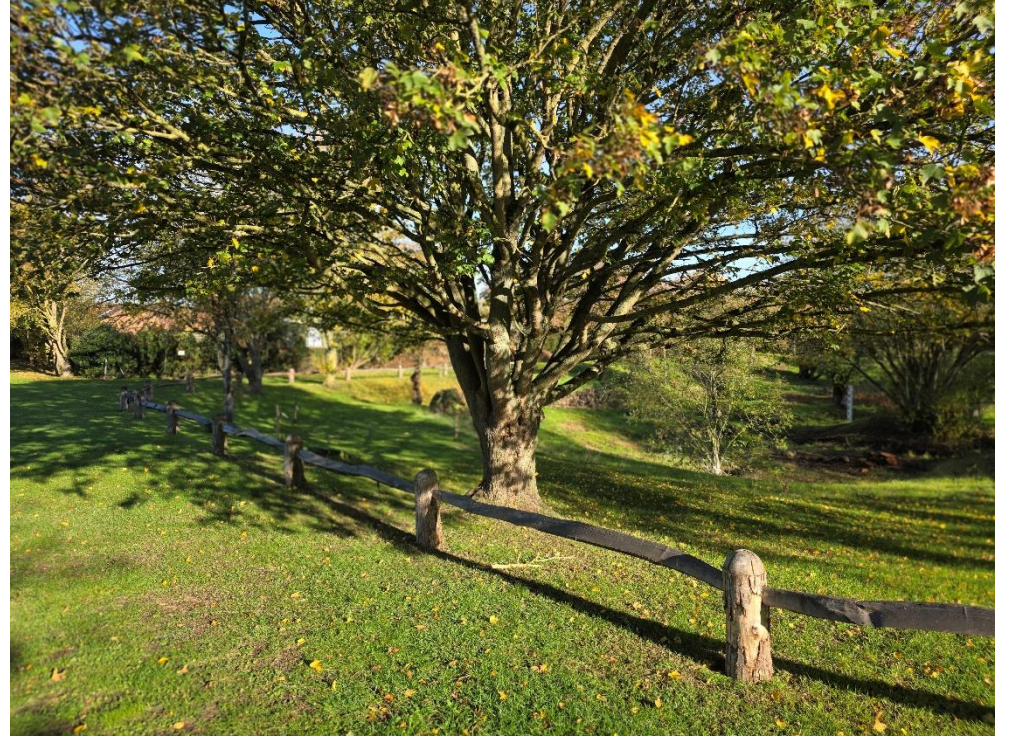
1J, 1K The side of the pond nearest to the play areas has a knee high, single bar rustic fence installed (<http://horseshoe.braced.showrooms>).

| Entity or Hazard | Potential Harm | Control measures in place | C | L | RR | Additional control measures required | C | L | ARR | Pics |
|---|---|---|---|---|---|---|---|---|---|---|
| Pond.<br>Accessible, uneven banks near water of unknown and varying depths. | Slips, trips or falls into potentially hazardous water.<br>Potential for cuts, bruises, sprains, fractures and drowning. | <p>The pond can be dry for around 6-months of the year.</p> <p>The side of the pond nearest to the play areas has a knee high, single bar rustic fence installed to deter access.</p> <p>Wide walkways around the pond are well maintained.</p> <p>Whilst the pond base is very uneven, a staff gauge has been installed to provide an indication of the water level up to 5-feet or 1.5 metres.</p> <p>Users of the area have a legal duty to take reasonable care of their own safety.</p> <p>Signage reminds park users that "Children should be supervised at all times".</p> <p>A small life ring and rope have been installed.</p> <p>The Parish Council inspects and maintains the pond and recreation ground.</p> | 5 | 2 | 10 | <p>Warning signage should also highlight uneven ground and risk of falling as potential hazards.</p> <p>The side of the pond furthest from the play areas has accessible banks 10 metres from a public footpath. Consider if a knee high, single bar rustic fence to deter access would be of benefit in this area.</p> <p>Consider if the staff gauge needs to be taller for higher water levels.</p> <p>Continue the programme of inspection and maintenance.</p> <p>The day of the audit was sunny and dry. Whilst this allowed observation of the pond base without water, the next audit should be scheduled for January 2027 which is likely to be a higher water level.</p> | 5 | 2 | 10 | 1A,<br>1B,<br>1F,<br>1G,<br>1J,<br>1K,<br>1P,<br>1Q,<br>1R,<br>1U,<br>1V,<br>1W. |

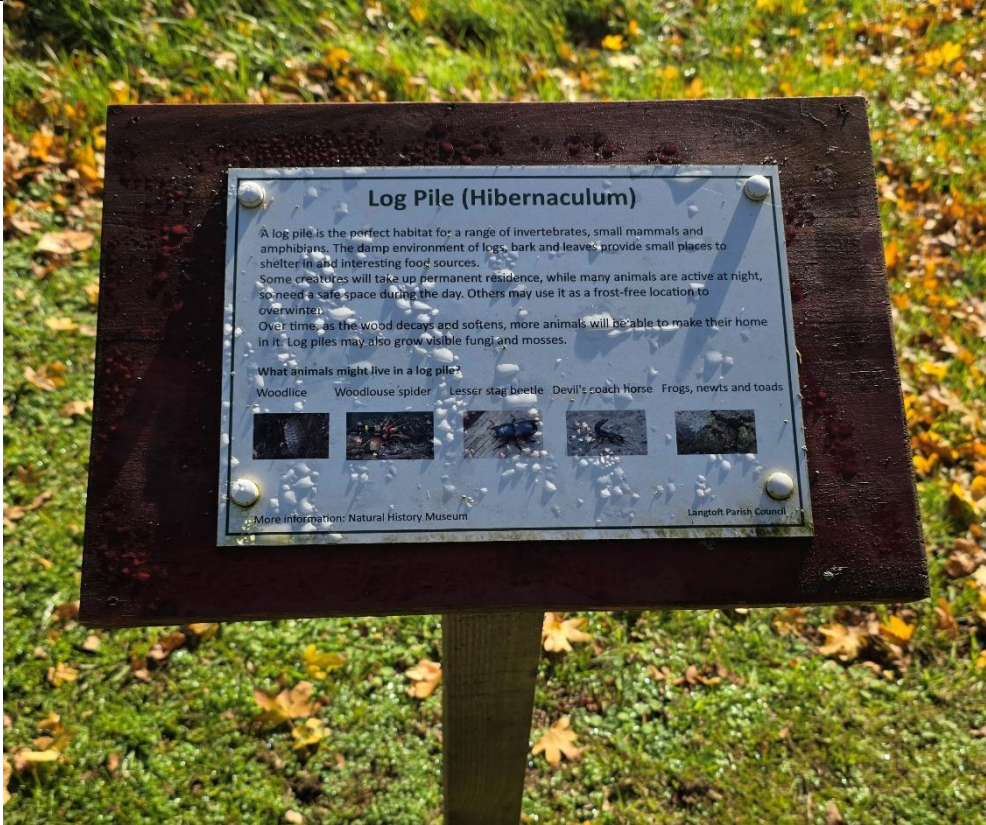
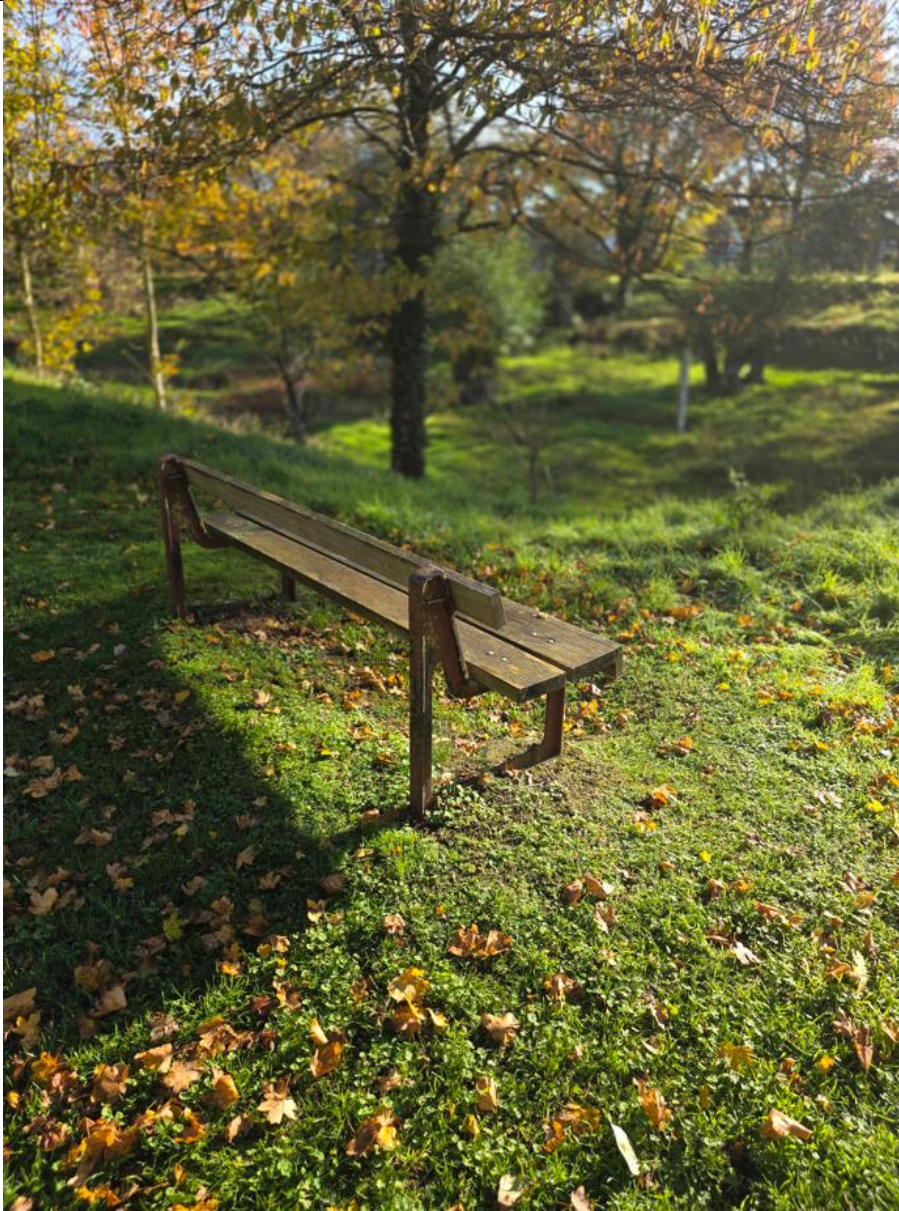
1L, 1M, A sign and bench adjacent to the Log Pile feature (///slipping.nudge.subsets).

| Entity or Hazard | Potential Harm | Control measures in place | C | L | RR | Additional control measures required | C | L | ARR | Pics |
|---|---|---|---|---|---|---|---|---|---|---|
| The "Log Pile" | Fall from height onto uneven ground or into water.<br>Potential for cuts, bruises, sprains, fractures and drowning. | The feature has been built well and is solid at present.<br>The sheer edge of the "Log Pile" is reasonably well defined and clearly visible in daylight.<br>The Parish Council inspects and maintains the pond and recreation ground. | 4 | 3 | 12 | Warning signage should also highlight uneven ground and risk of falling as potential hazards.<br>Continue the programme of inspection and maintenance.<br>The day of the audit was sunny and dry. Whilst this allowed observation of the pond base without water, the next audit should be scheduled for January 2027 when the ground may be boggy, slippery and possibly icy.<br>An inspection in the evening would also be useful to gauge how visible this area is in borrowed lighting. | 4 | 2 | 8 | 1L,<br>1N,<br>1O. |

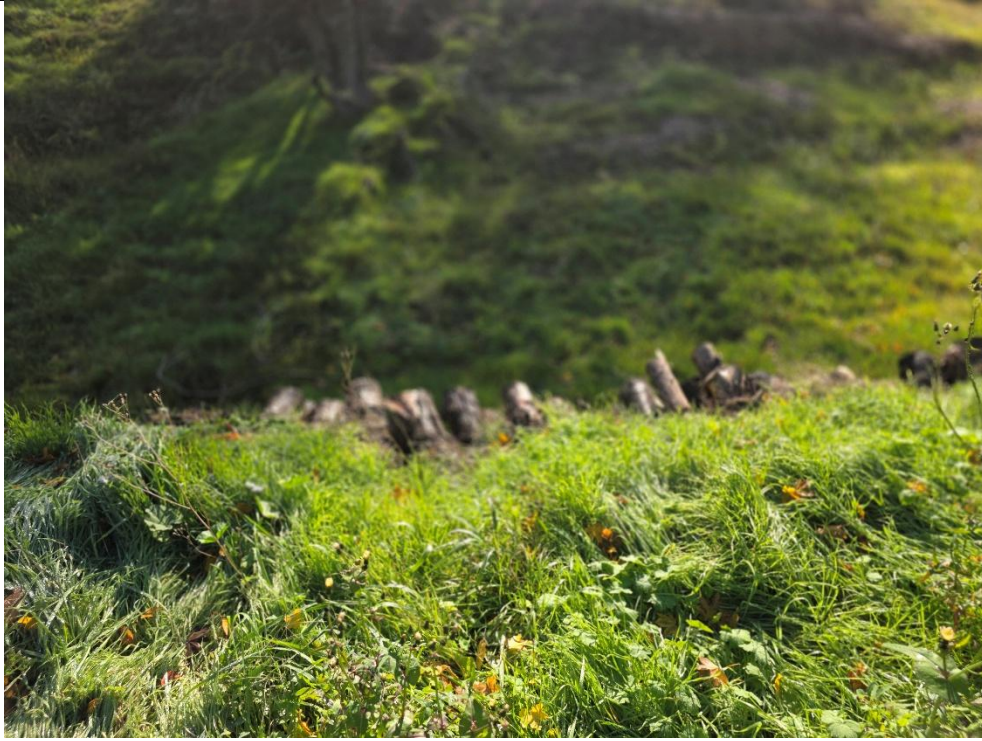
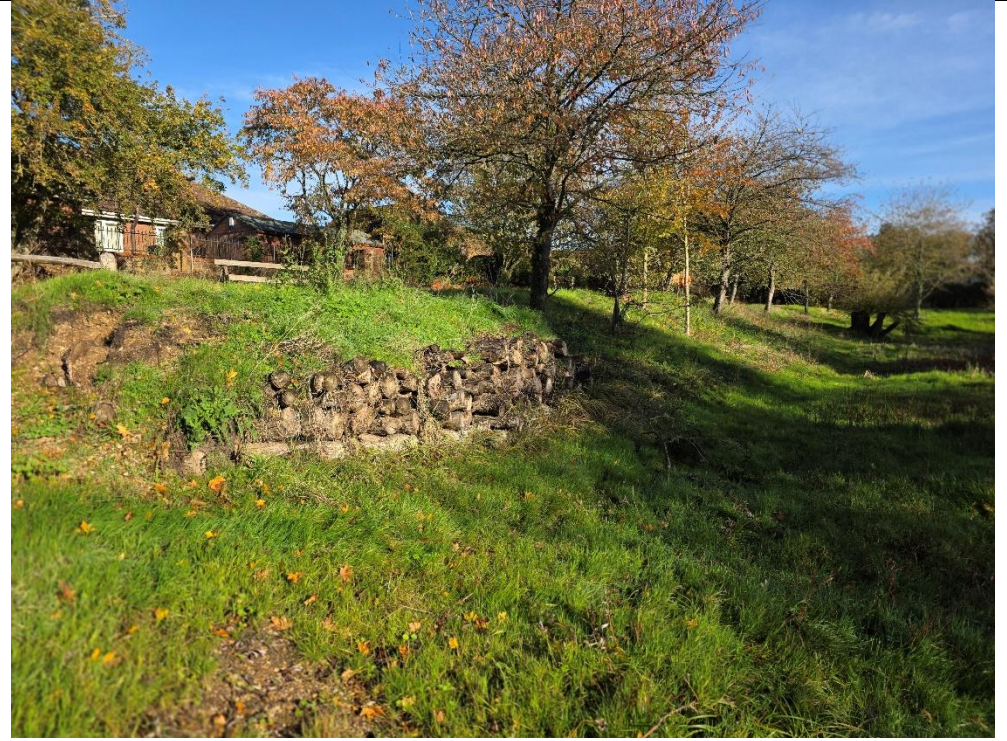
1N, 1O, The Log Pile feature presents a 1-2 metre fall hazard. The feature may also become unstable as the logs rot over time (///slipping.nudge.subsets).

| Entity or Hazard | Potential Harm | Control measures in place | C | L | RR | Additional control measures required | C | L | ARR | Pics |
|---|---|---|---|---|---|---|---|---|---|---|
| The sloping sides of the pond | Slips trips or falls onto ground or into water at the same level or from height.<br>The resulting harm could include cuts, bruises, sprains, fractures or drowning. | <p>The bank gradients vary significantly from sheer drops such as at the Log Pile to gentle accessible slopes.</p> <p>The pond can be dry for around 6-months of the year. During this period, very uneven ground is easily accessible.</p> <p>The side of the pond nearest to the play areas has a knee high, single bar rustic fence installed to deter access.</p> <p>Wide walkways around the pond are well maintained.</p> <p>Users of the area have a legal duty to take reasonable care of their own safety.</p> <p>Signage reminds park users that “Children should be supervised at all times”.</p> <p>A small life ring and rope have been installed.</p> <p>The Parish Council inspects and maintains the pond and recreation ground.</p> | 4 | 2 | 8 | <p>Warning signage should also highlight uneven ground and risk of falling as potential hazards.</p> <p>Continue the programme of inspection and maintenance.</p> | 4 | 2 | 8 | 1M,<br>1N,<br>1O,<br>1S,<br>1U,<br>1V,<br>1W. |

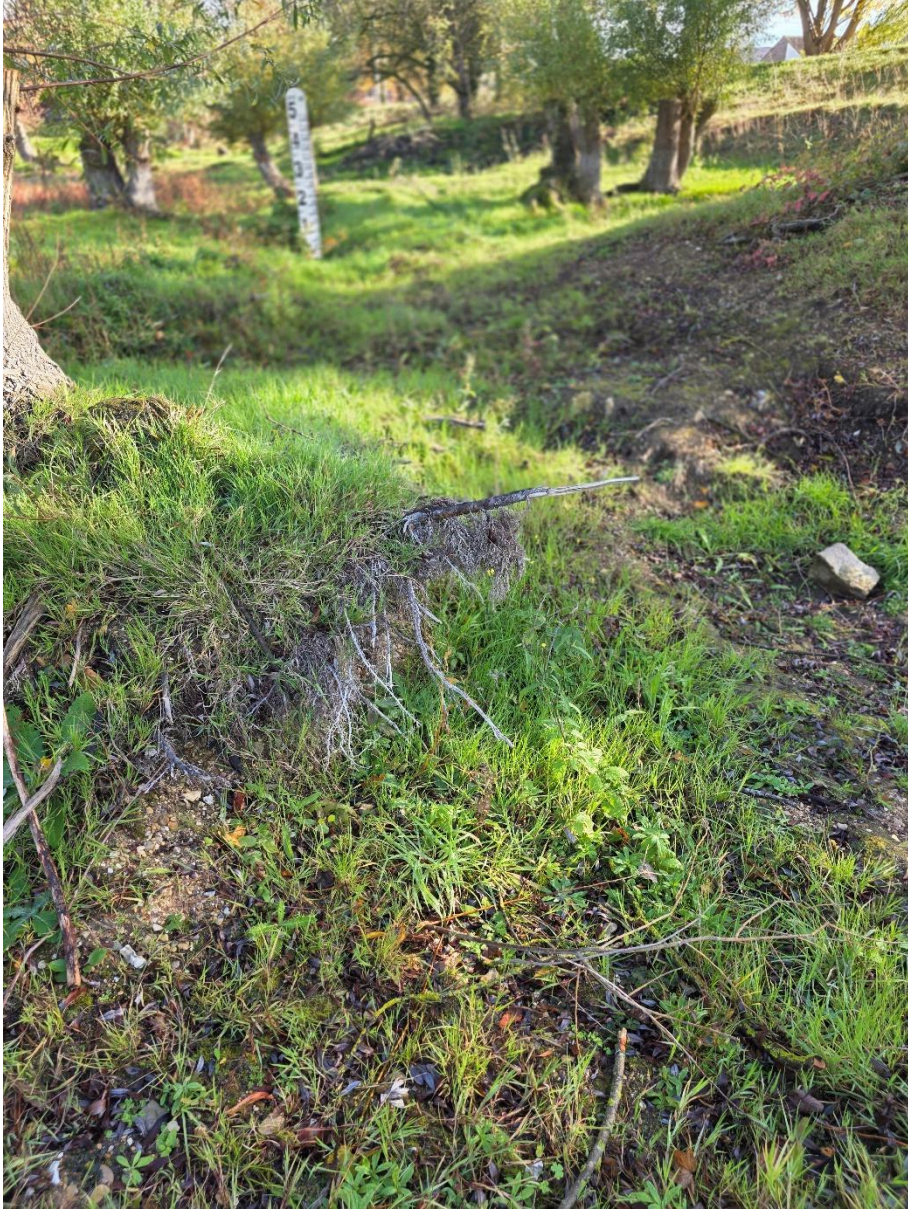
1P, 1Q, The base of the pond is reasonably solid, very uneven and stoney in places. Trees and stumps from cleared trees are numerous (///crispy.scatter.chuck).

| Entity or Hazard | Potential Harm | Control measures in place | C | L | RR | Additional control measures required | C | L | ARR | Pics |
|---|---|---|---|---|---|---|---|---|---|---|
| Dry pond basin. Accessible uneven ground that changes with weather. | Slips, trips or falls onto ground.<br>Potential for cuts, bruises, sprains and fractures. | <p>The pond can be dry for around 6-months of the year. During this period, very uneven ground is easily accessible.</p> <p>The side of the dry pond basin nearest to the play areas has a knee high, single bar rustic fence installed to deter access.</p> <p>Wide walkways around the dry pond basin are well maintained.</p> <p>Users of the area have a legal duty to take reasonable care of their own safety.</p> <p>Signage reminds park users that "Children should be supervised at all times".</p> <p>The Parish Council inspects and maintains the dry pond basin and recreation ground.</p> | 4 | 2 | 8 | <p>Warning signage should also highlight uneven ground and risk of falling as potential hazards.</p> <p>The side of the dry pond basin furthest from the play areas has accessible banks 10 metres from a public footpath. Consider if a knee high, single bar rustic fence to deter access would be of benefit in this area.</p> <p>Continue the programme of inspection and maintenance.</p> | 4 | 2 | 8 | 1A, 1B, 1F, 1G, 1J, 1K, 1P, 1Q, 1U, 1V, 1W. |
