**AquaServe Management Ltd**

| <b>Water:</b> | Village Pond (East End Pond) | <b>Total Area:</b> | 1,316 square metres |

## Waterway Health and Safety Risk Assessment

East End Pond, East End Play Area, Langtoft, Peterborough, PE6 9LP

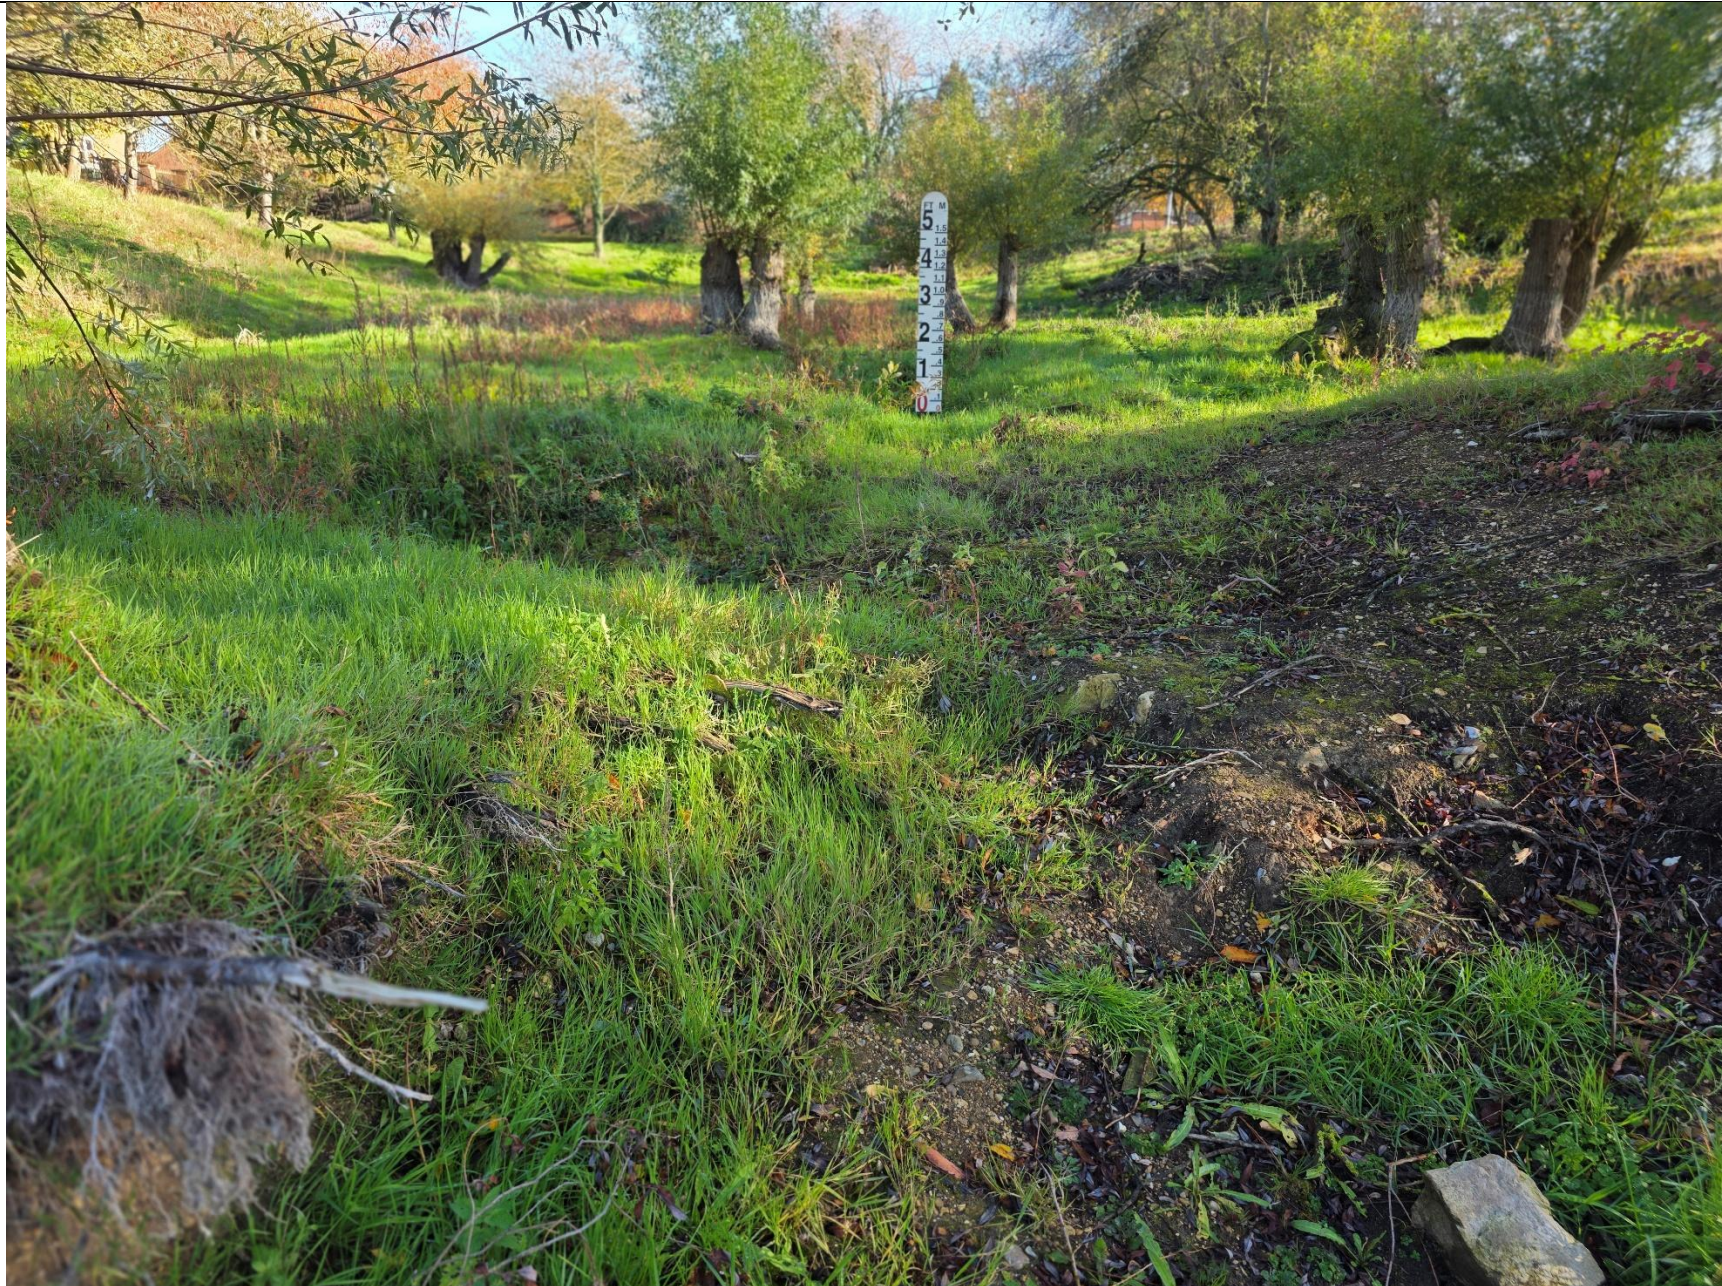
1R, A staff gauge has been installed to provide a quick, visual measurement of the water level up to 5-feet or 1.5 metres. Correspondence has suggested that water levels can reach 2-metres. If this is the case, the staff gauge could be completely submerged at high water levels (<http://threaded.nitrogen.tickets>).

| Description | Priority |
|---|---|
| <p>Consider if the staff gauge needs to be taller for higher water levels.</p> | 4 |

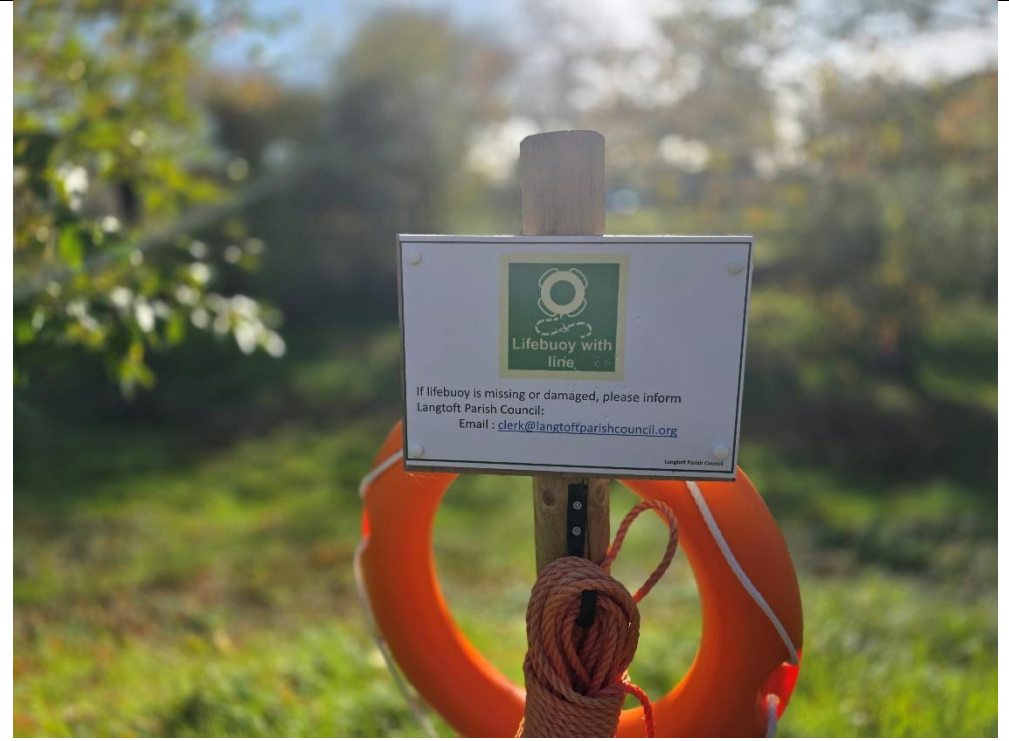
1S, 1T, A small life ring and rope have been installed adjacent to an unguarded section of bank and are in good order (///reports.condensed.springing).

| Entity or Hazard | Potential Harm | Control measures in place | C | L | RR | Additional control measures required | C | L | ARR | Pics |
|---|---|---|---|---|---|---|---|---|---|---|
| Public Rescue Equipment (PRE) | Loss of life or delay in rescue if equipment is missing, damaged or otherwise inaccessible. | <p>The pond can be dry for around 6-months of the year.</p> <p>The side of the pond nearest to the play areas has a knee high, single bar rustic fence installed to deter access.</p> <p>Wide walkways around the pond are well maintained.</p> <p>Whilst the pond base is very uneven, a staff gauge has been installed to provide an indication of the water level up to 5-feet or 1.5 metres.</p> <p>Users of the area have a legal duty to take reasonable care of their own safety.</p> <p>Signage reminds park users that "Children should be supervised at all times".</p> <p>A small life ring and rope have been installed.</p> <p>A sign on the lifebuoy stand states "If lifebuoy is missing or damaged, please inform Langtoft Parish Council" and provides an email address.</p> <p>The Parish Council inspects and maintains the pond and recreation ground.</p> | 5 | 2 | 10 | <p>How useful a small life ring and rope would be in an emergency is uncertain. It is generally agreed however that the first action that should be taken if witnessing a fall into water is to alert the fire brigade, letting them know the precise location.</p> <p>An information sign (green background with white text and symbols) should be mounted on the lifebuoy stand stating, "In the event of a person falling into the water, DIAL 999 and ask for the FIRE BRIGADE". The sign should also quote the What3Words location <a href="http://reports.condensed.springing">"///reports.condensed.springing"</a>. This information would also be useful at the entrances to the park.</p> | 5 | 1 | 5 | 1S, 1T. |

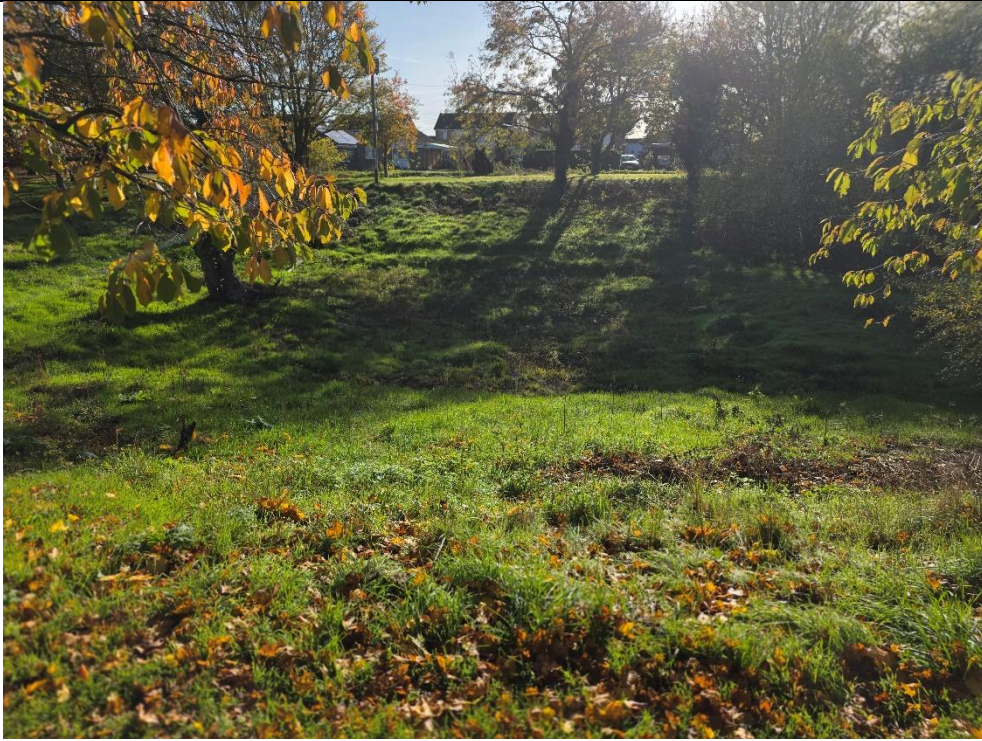
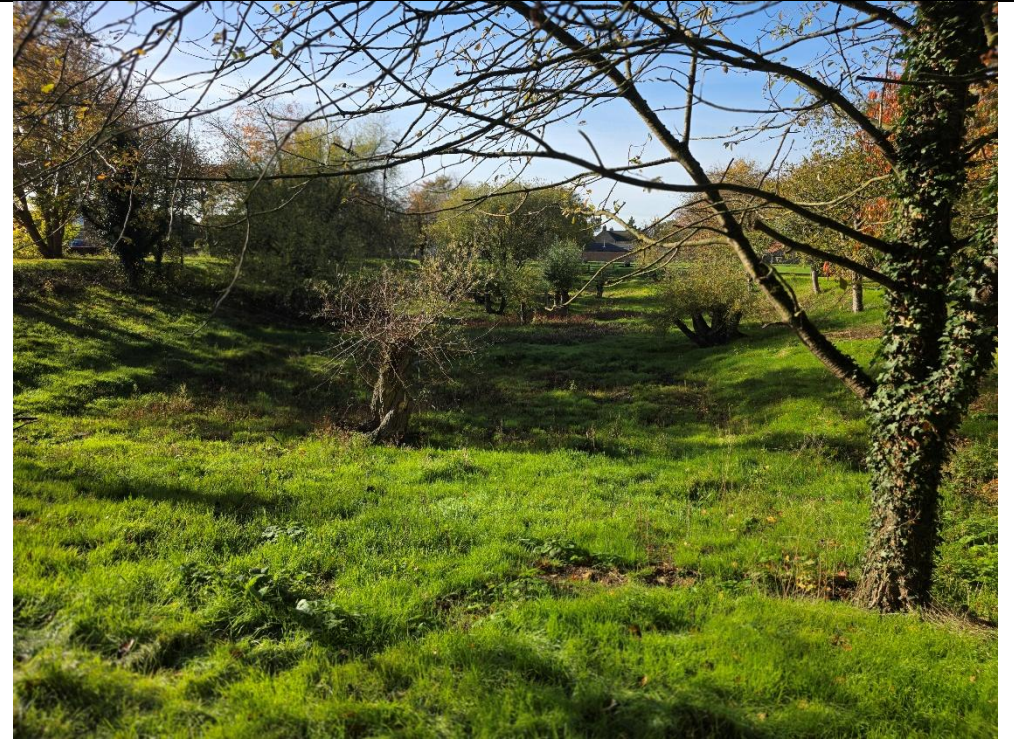
1U, 1V, The bank gradients vary significantly from sheer drops such as at the Log Pile to gentle slopes as shown below (///topping.shuttling.journey & ///inflation.sobs.blurred)

| Description | Priority |
|---|---|
| <p>The side of the pond furthest from the play areas has accessible banks 10 metres from a public footpath. Consider if a knee high, single bar rustic fence to deter access would be of benefit in this area.</p> | 3 |

| Entity or Hazard | Potential Harm | Control measures in place | C | L | RR | Additional control measures required | C | L | ARR | Pics |
|---|---|---|---|---|---|---|---|---|---|---|
| The sloping sides of the pond | Slips trips or falls onto ground or into water at the same level or from height.<br>The resulting harm could include cuts, bruises, sprains, fractures or drowning. | <p>The bank gradients vary significantly from sheer drops such as at the Log Pile to gentle accessible slopes.</p> <p>The pond can be dry for around 6-months of the year. During this period, very uneven ground is easily accessible.</p> <p>The side of the pond nearest to the play areas has a knee high, single bar rustic fence installed to deter access.</p> <p>Wide walkways around the pond are well maintained.</p> <p>Users of the area have a legal duty to take reasonable care of their own safety.</p> <p>Signage reminds park users that “Children should be supervised at all times”.</p> <p>A small life ring and rope have been installed.</p> <p>The Parish Council inspects and maintains the pond and recreation ground.</p> | 4 | 2 | 8 | <p>Warning signage should also highlight uneven ground and risk of falling as potential hazards.</p> <p>Continue the programme of inspection and maintenance.</p> | 4 | 2 | 8 | 1M,<br>1N,<br>1O,<br>1S,<br>1U,<br>1V,<br>1W. |

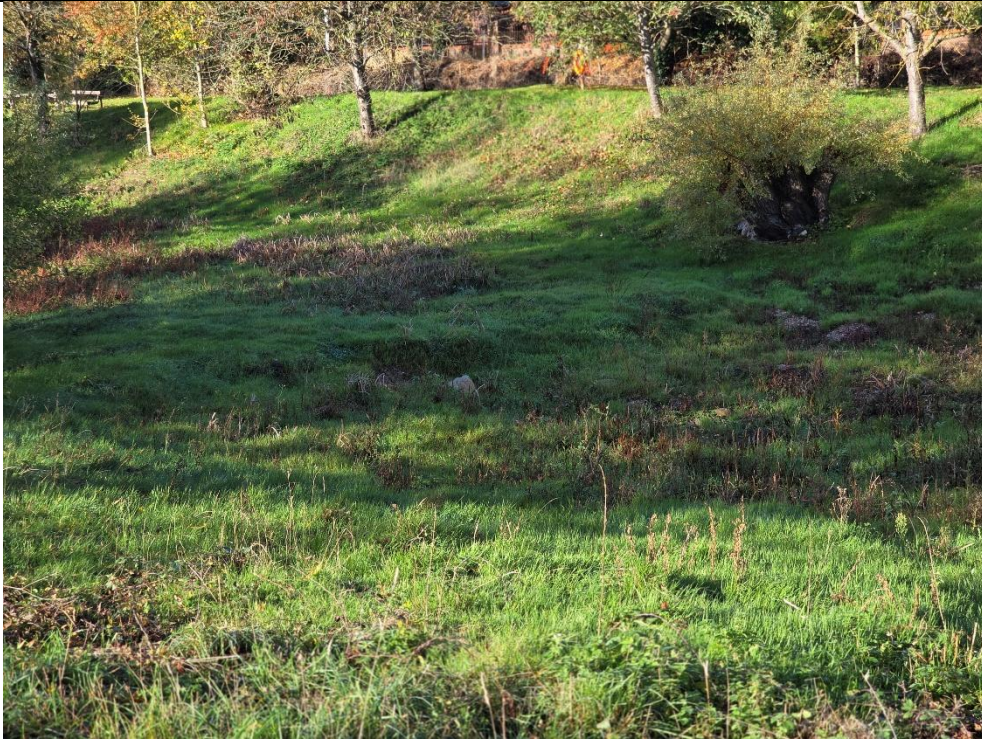
1W, Further evidence of varying slopes and uneven ground (///badge.coil.wing).

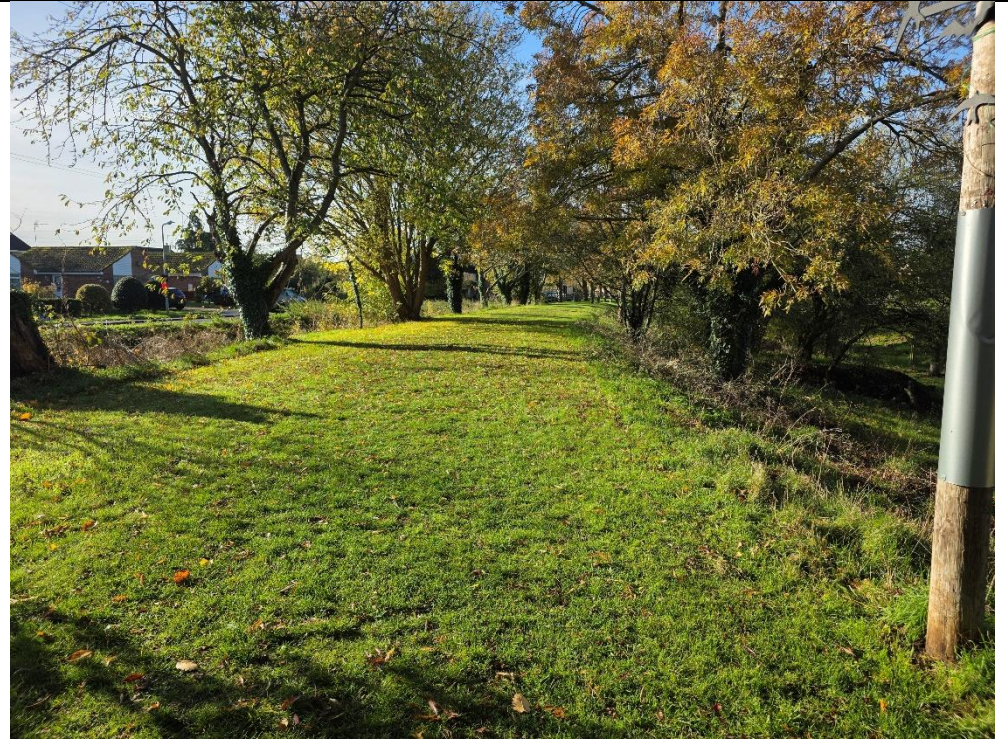
1X, Like the entire park area, this wide walkway between the pond and the ditch is well maintained (///afternoon.glides.informal).

| Entity or Hazard | Potential Harm | Control measures in place | C | L | RR | Additional control measures required | C | L | ARR | Pics |
|---|---|---|---|---|---|---|---|---|---|---|
| Accessible uneven ground (excluding inside the pond area) that changes with weather and burrowing wildlife. | Slips, trips or falls onto ground or into hazardous water.<br><br>Potential for cuts, bruises, sprains, fractures and drowning. | The Parish Council inspects and maintains the pond and recreation ground.<br><br>Walkway and play areas are well maintained.<br><br>Users of the area have a legal duty to take reasonable care of their own safety.<br><br>Signage reminds park users that "Children should be supervised at all times". | 3 | 2 | 6 | Warning signage should also highlight uneven ground and risk of falling as potential hazards.<br><br>Continue the programme of inspection and maintenance.<br><br>The day of the audit was sunny and dry. Whilst this allowed observation of the pond base without water, the next audit should be scheduled for January 2027 when the ground may be boggy, slippery and possibly icy. | 3 | 2 | 6 | 1P,<br>1Q,<br>1U,<br>1V,<br>1W,<br>1X. |

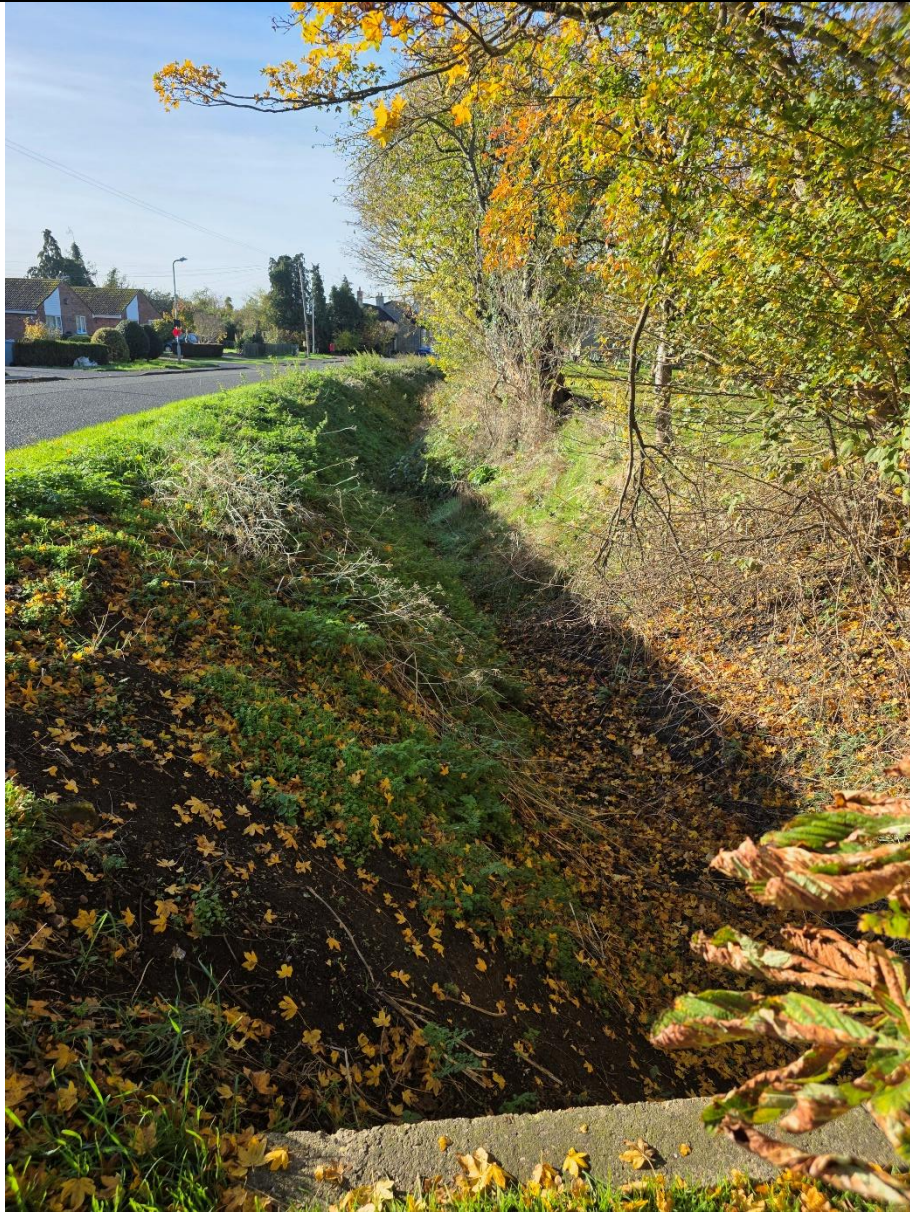
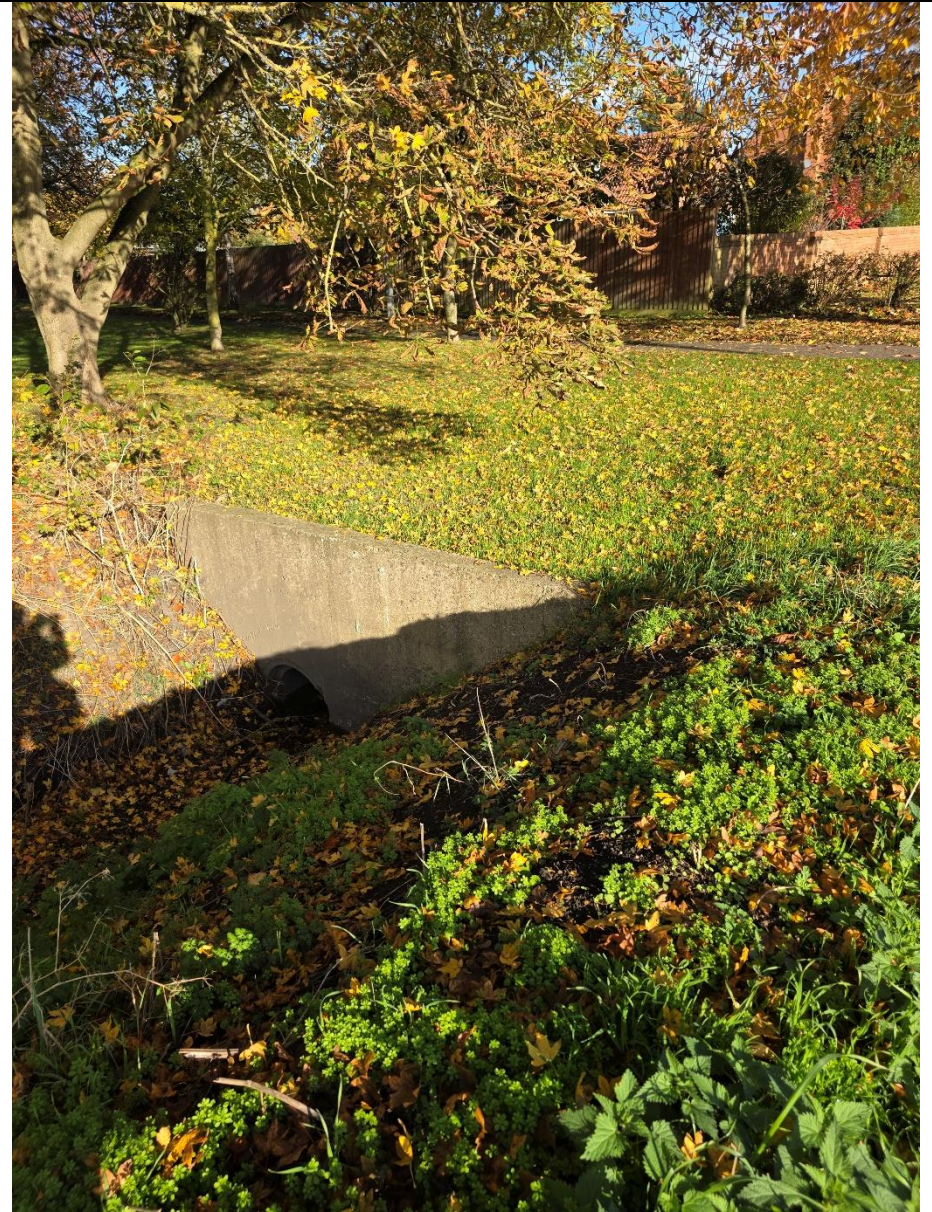
1Y, 1Z, An unguarded, accessible culvert is a 2m fall hazard. This 2m deep drainage ditch with steep sides runs along the side of the park nearest the road (///pulled.ourselves.slippers).

| Description | Priority |
|---|---|
| <p>There is an inconsistency created by fencing the culvert near the gate and stile entrance to the park and not fencing the equally accessible culvert at the footpath entrance. A fall from the latter is foreseeable, could result in significant harm and the inconsistency in guarding could increase culpability.</p> <p>It is strongly recommended that the culvert at the footpath entrance to the park should be fenced.</p> | 1 |
| <p>Fitting sturdy fixed trash guards to the culvert pipes could be considered.</p> | 4 |

| Entity or Hazard | Potential Harm | Control measures in place | C | L | RR | Additional control measures required | C | L | ARR | Pics |
|---|---|---|---|---|---|---|---|---|---|---|
| Culvert pipes | <p>Larger culverts can be entered by people who could be trapped or injured by blockages or drowned by water surges.</p> | <p>The two culvert pipes are estimated at between 300mm and 400mm in diameter. The ditch is deep, has steep sides and it is not easy to access the pipes.</p> <p>Whilst it is unlikely, a smaller child could enter the pipes</p> | 5 | 2 | 8 | <p>Fitting sturdy fixed trash guards to the culvert pipes could be considered.</p> | 5 | 1 | 5 | 1I, 1Z. |

| Entity or Hazard | Potential Harm | Control measures in place | C | L | RR | Additional control measures required | C | L | ARR | Pics |
|---|---|---|---|---|---|---|---|---|---|---|
| Drainage ditch.<br>2-metre-deep ditch with steep sides | Slips, trips or falls from height into ditch.<br><br>Potential for cuts, bruises, sprains and fractures. | <p>Wide walkways around the park are well maintained. There is no obvious reason why users would approach the ditch other than play.</p> <p>There is no pavement installed on the roadside adjacent to the ditch.</p> <p>Vegetation is maintained in a manner to deter access to the ditch and culverts. There was no evidence of bridge building</p> <p>Users of the area have a legal duty to take reasonable care of their own safety.</p> <p>Signage reminds park users that "Children should be supervised at all times".</p> <p>The Parish Council inspects and maintains the pond and recreation ground.</p> | 4 | 2 | 8 | <p>Warning signage should also highlight uneven ground and risk of falling as potential hazards.</p> <p>Continue the programme of inspection and maintenance.</p> <p>The day of the audit was sunny and dry. Whilst this allowed observation of the ditch without water, the next audit should be scheduled for January 2027 when there may be water in the ditch, possibly icy.</p> <p>An inspection in the evening would also be useful to gauge how visible this area is in borrowed lighting.</p> | 4 | 1 | 4 | 1H,<br>1I,<br>1Y,<br>1Z,<br>1AA,<br>1AD. |

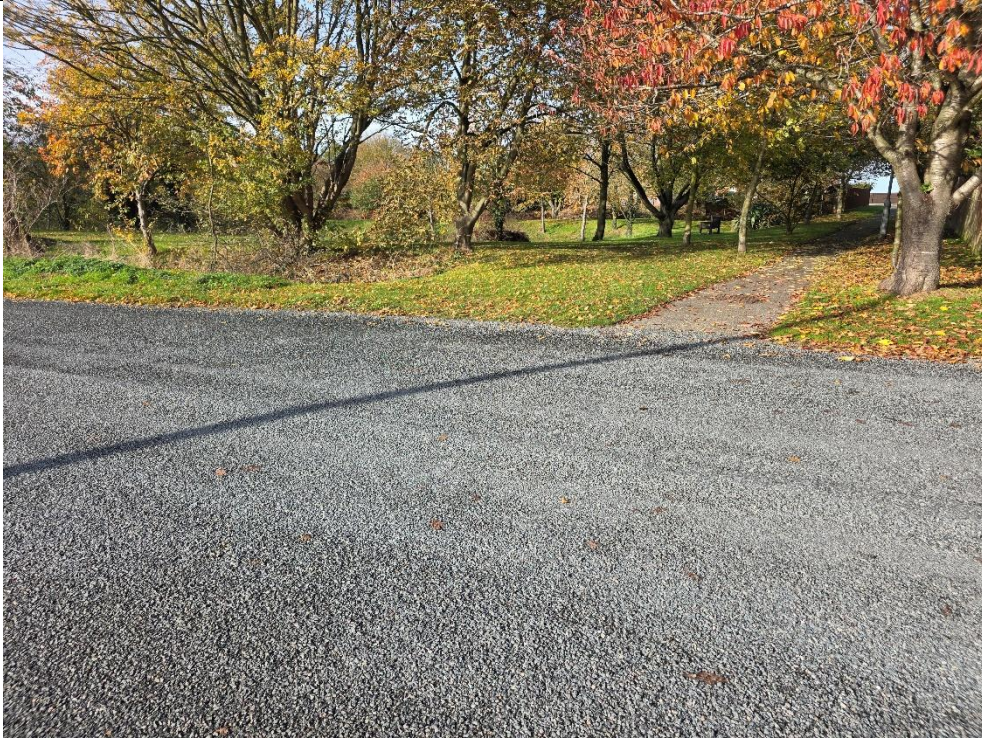
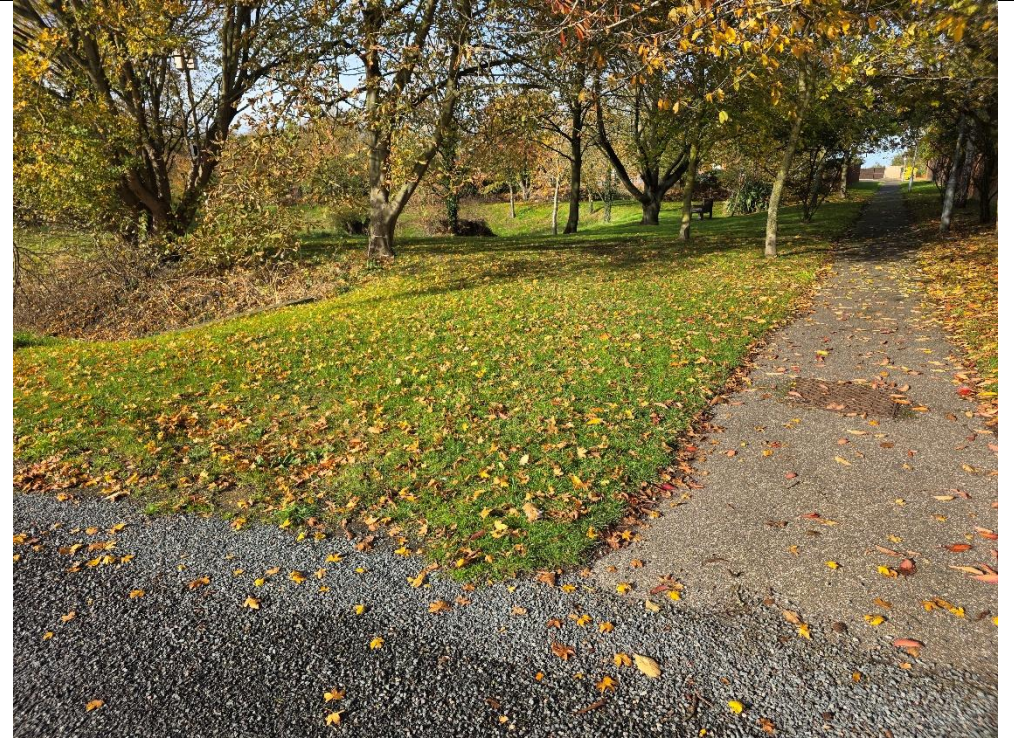
1AA, 1AB, This pathway with access to the pond, recreational and sports areas is 10 metres from the unguarded, accessible culvert (///pulled.ourselves.slippers).

| Entity or Hazard | Potential Harm | Control measures in place | C | L | RR | Additional control measures required | C | L | ARR | Pics |
|---|---|---|---|---|---|---|---|---|---|---|
| Culverts | <p>Falls from structures onto ground or into water from height.</p> <p>The resulting harm could include cuts, bruises, sprains, fractures or drowning.</p> <p>Harm caused by a fall from a built structure is more likely to be result in a claim or liability.</p> | <p>Wide walkways around the park are well maintained. There is no obvious reason why users would approach the culverts other than play.</p> <p>Whilst the culvert could still be accessed, the access to one of the two culverts was deterred by a 1.5 metre tall, 4-bar fence.</p> <p>There is no pavement installed on the roadside adjacent to the ditch. Vegetation is maintained in a manner to further deter access to the ditch and culverts.</p> <p>Users of the area have a legal duty to take reasonable care of their own safety.</p> <p>Signage reminds park users that "Children should be supervised at all times".</p> <p>The Parish Council inspects and maintains the pond and recreation ground.</p> | 4 | 3 | 12 | <p>There is an inconsistency created by fencing the culvert near the gate and stile entrance to the park and not fencing the equally accessible culvert at the footpath entrance. A fall from the latter is foreseeable, could result in significant harm and the inconsistency in guarding could increase culpability.</p> <p>It is strongly recommended that the culvert at the footpath entrance to the park should be fenced.</p> <div data-bbox="1361 644 1496 861"> <p><b>Danger</b><br/>Risk of falling</p> </div> <p>A "Danger, Risk of falling" sign on both fences could further decrease the risks of harm and litigation.</p> <p>Warning signage should also highlight uneven ground and risk of falling as potential hazards.</p> <p>Continue the thoughtful programme of inspection and maintenance.</p> | 4 | 2 | 8 | 1H, 1I, 1Z, 1AA, 1AB. |

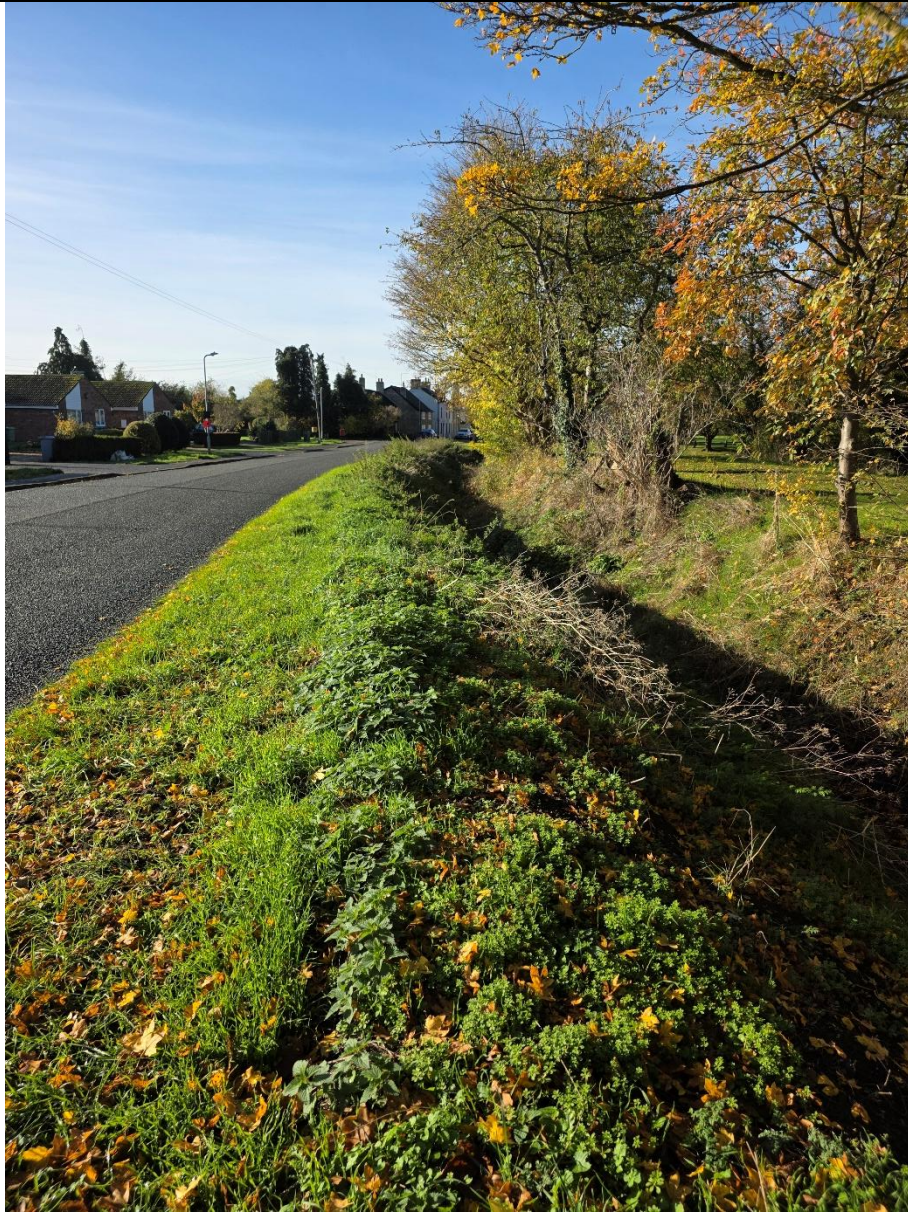
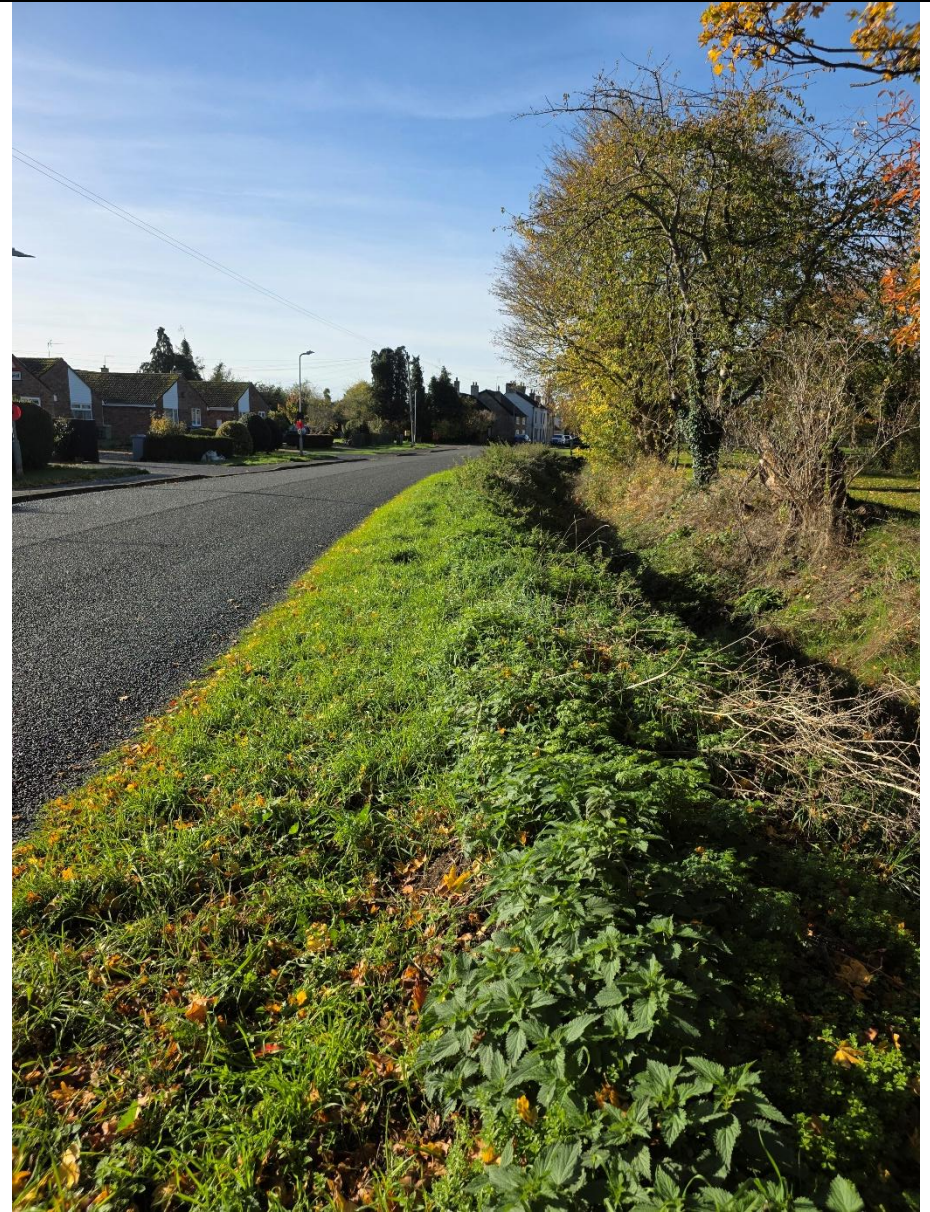
1AC, 1AD, There is no pavement installed on the roadside adjacent to the ditch. Vegetation is maintained in a manner to deter access to the ditch and there was no evidence of bridge building (///reds.swooned.curable).
